**Local Land
Services**
South East

Supporting Information for the development of a River Rehabilitation Plan for Araluen Creek and Tributaries.

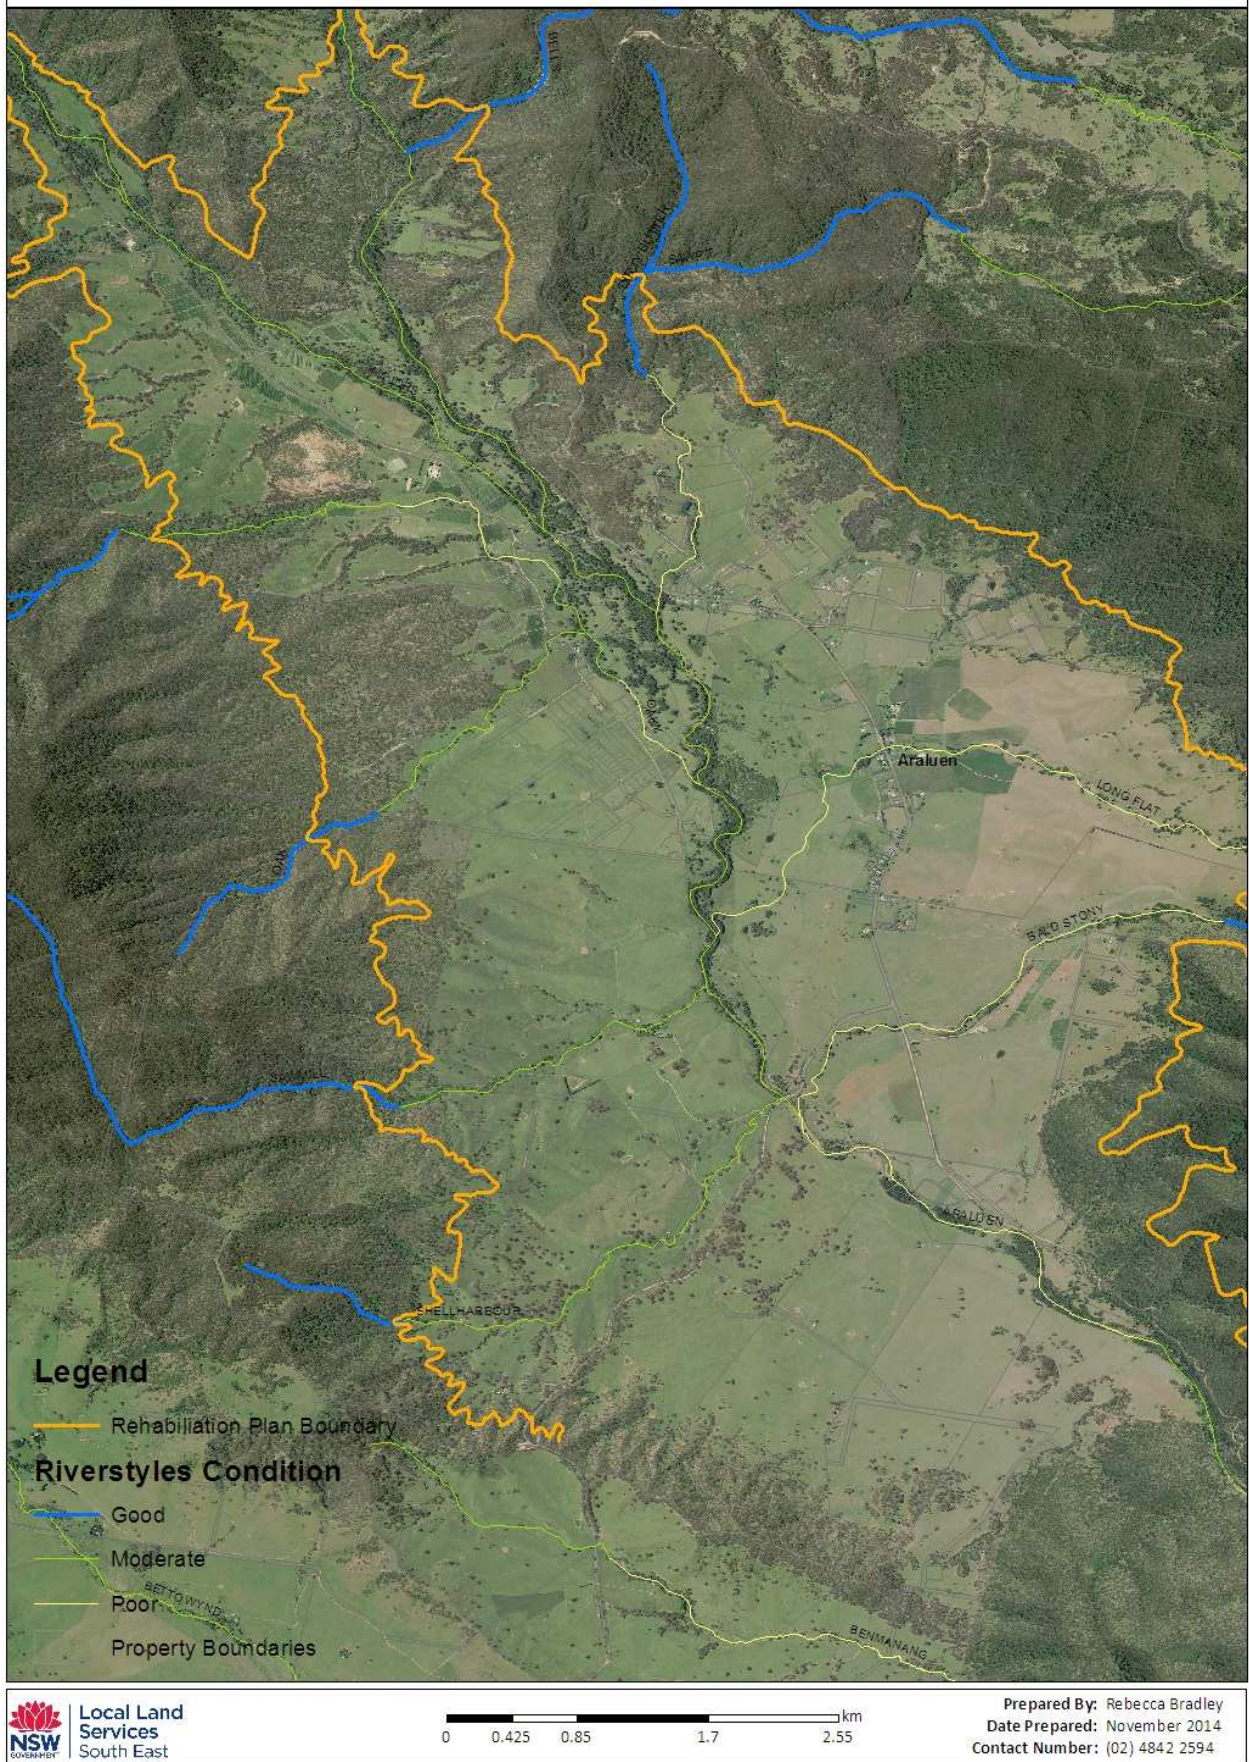
Figure 3: Geomorphic Condition

According to Riverstyles assessment (2012), the geomorphic condition of the eastern tributaries and a majority of Araluen Creek is 'moderate' transitioning to a poor condition downstream of the Nerringla Road crossing. The definition of 'moderate' condition being:

According to this same assessment, the geomorphic condition of the western tributaries is predominantly 'poor' condition. The definition of 'poor' condition being:

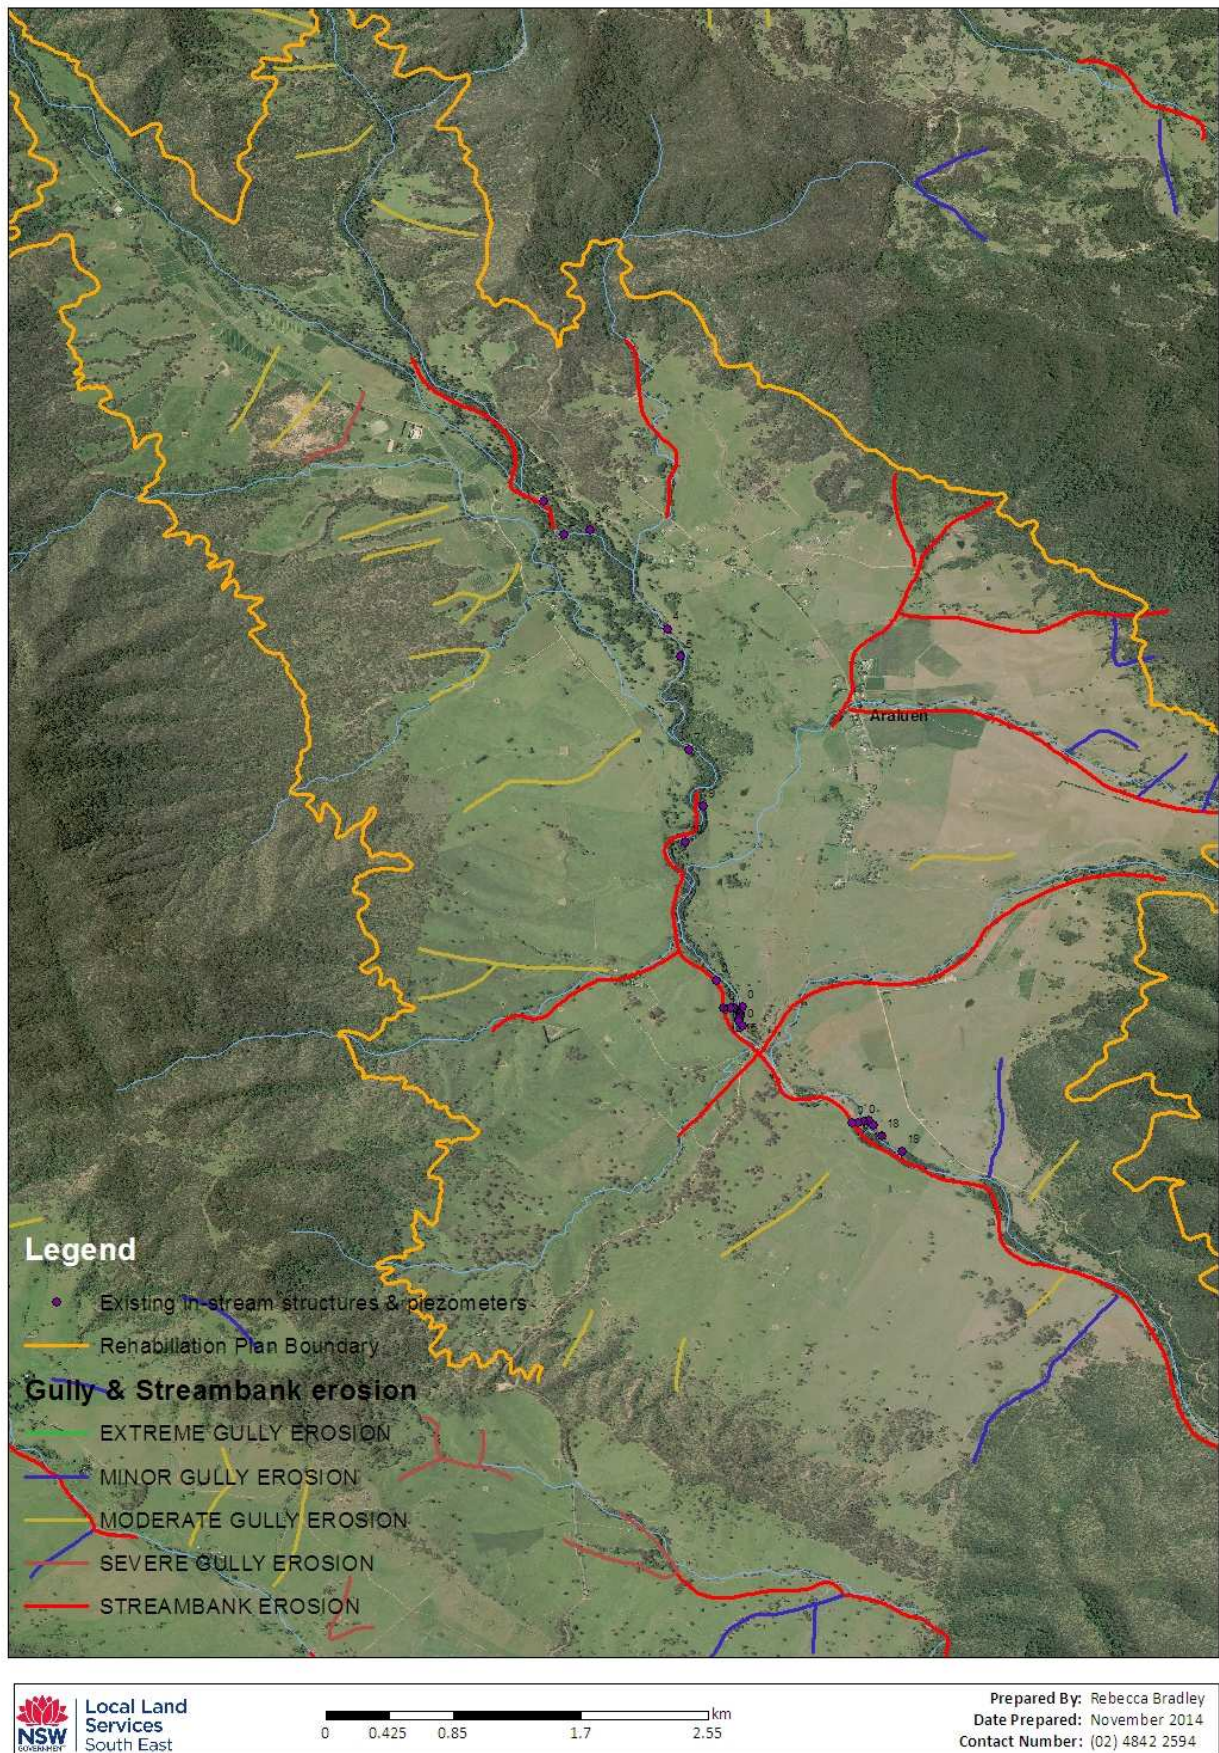
Upper Deua Landcare Group has spent considerable time identifying and rehabilitating areas of streambank and streambed erosion along Araluen Creek, within these areas identified on the following map. Recent assessment of past works has identified areas for repair to ensure on-going effective erosion control. Without maintenance to existing structures, active erosion may again occur along sections of Araluen Creek.

Tributaries to araluen Creek show signs of historical erosion but, in general, have stabilised without evidence of substantial movement, ensuring stability in lateral and vertical movement within Araluen Creek will assist in reducing active erosion within tributaries.

Figure 4: Potential Erosion & existing in-stream works (piezometers identified with the number 0, existing structures numbered 1 – 19).

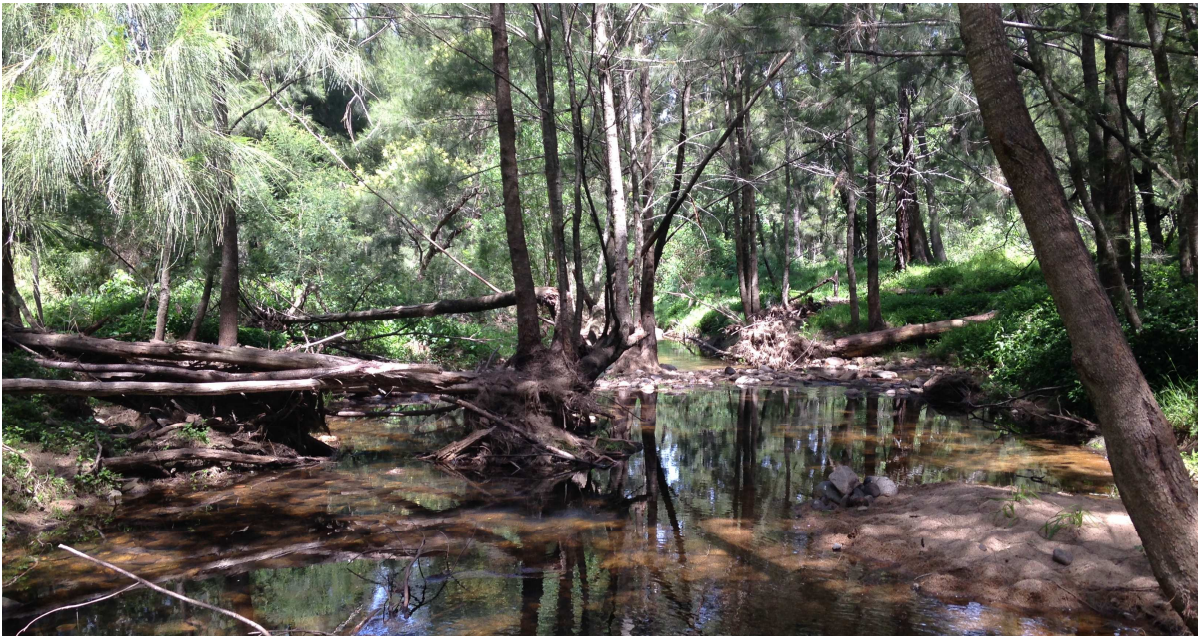
Figure 5: Vegetation along Araluen Creek, upstream of the Majors Creek Bridge (mature *Casuarina*, fallen timber and presence of weeds including blackberry, ivy).

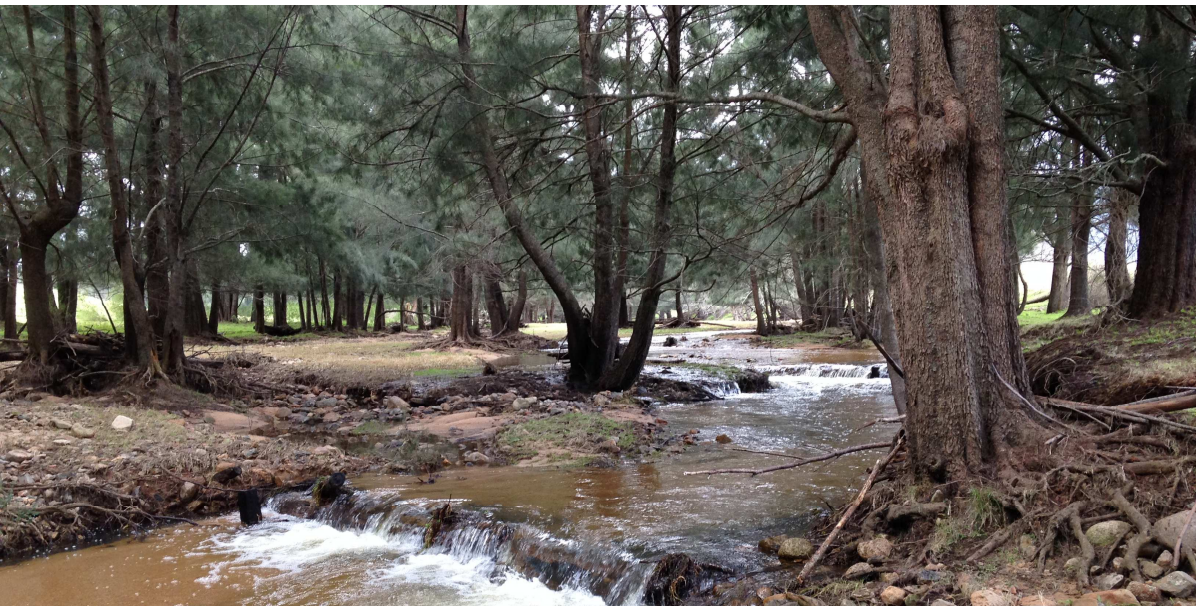
Figure 7: A view of riparian vegetation along Araluen Creek (immediately upstream of Nerringla Road Bridge), where a presence of grazing livestock has impacted on the presence of an understorey.

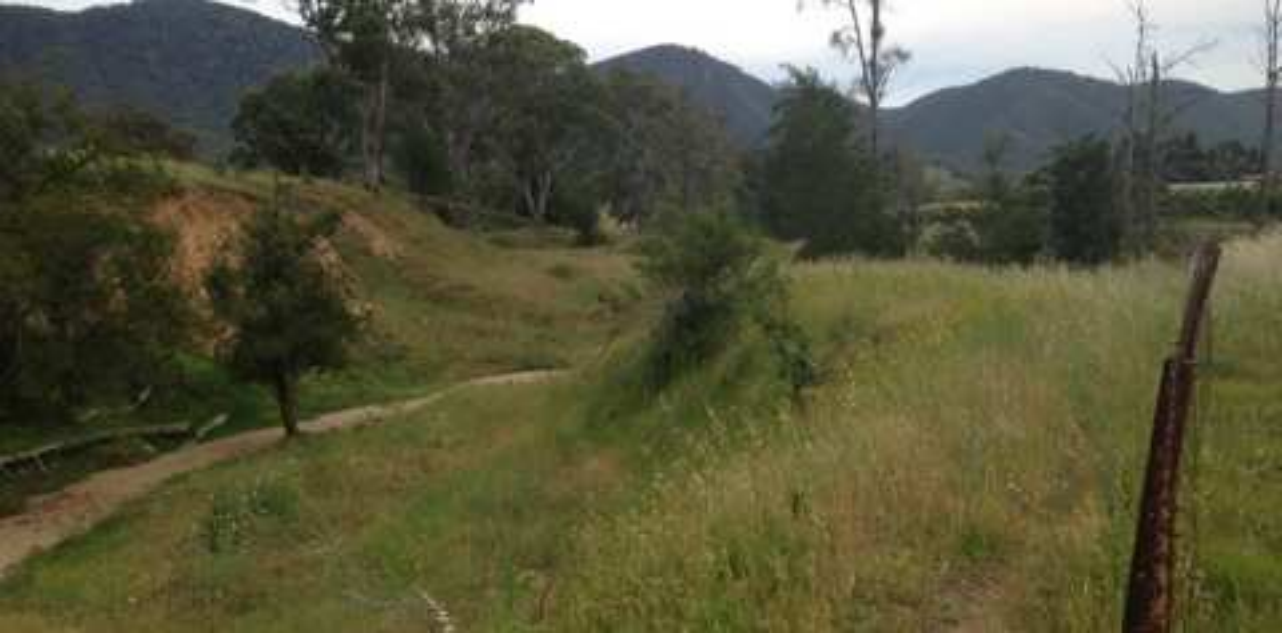
Figure 8: Oaky Creek, note the dry creek bed and scattered mature trees but generally an absence of native vegetation.

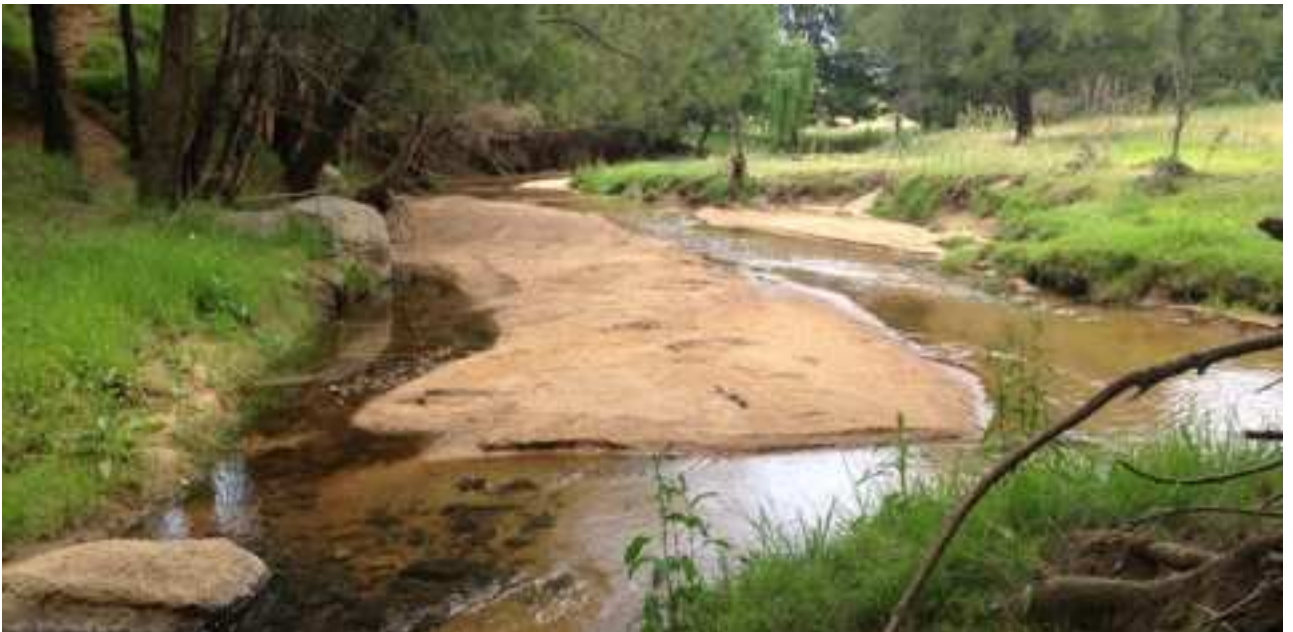
Figure 2: Incised stream downstream of structure 15 with mobile sediment and eroding streambank (top left of the view), would benefit from placement of an in-stream structure, raising bed levels.

- Below all structures there is opportunity to build an additional streambed control structure to raise bed levels and assist trapping sediment and securing the existing works.

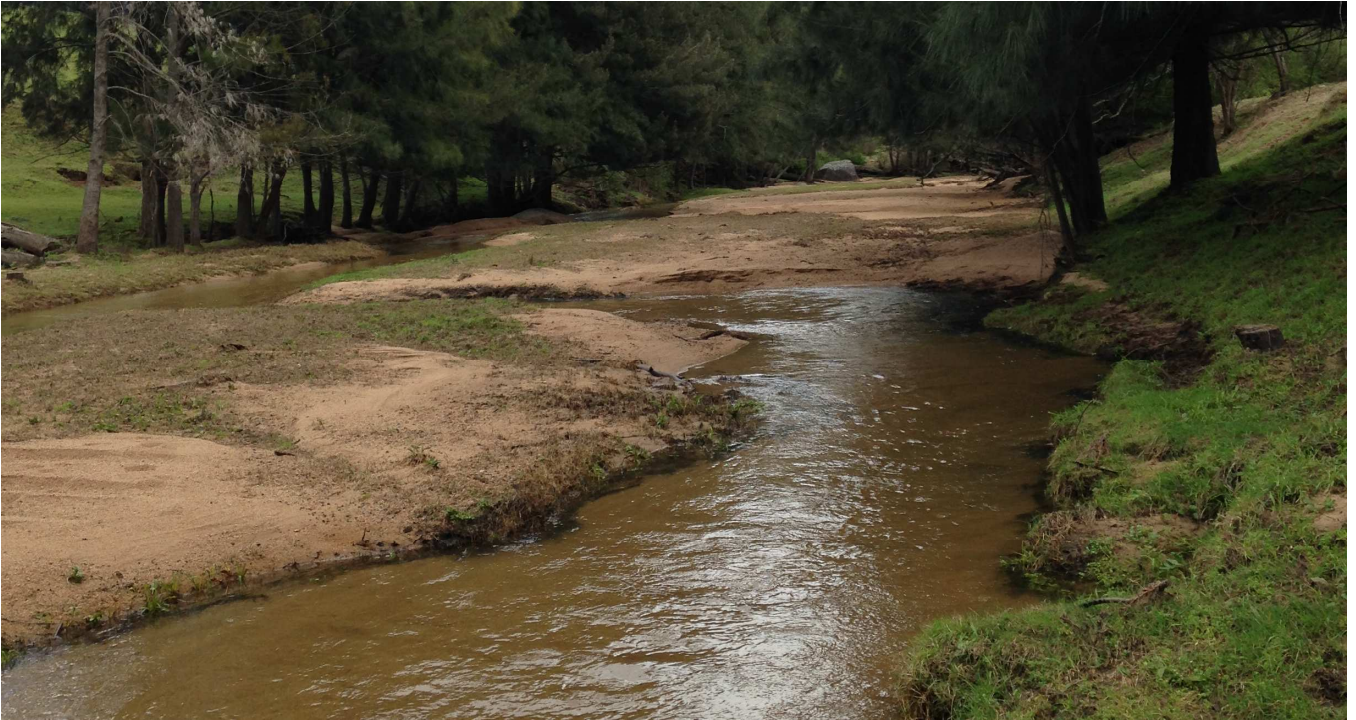
- Structures 15, 14, 13 and 12 are all clustered fairly close together and functioning well to manage water flows and retain bed stability. However upstream of this area, there remains significant sand accumulation which has the potential to travel to downstream areas as the existing structures are reaching their capacity for raising/ stabilising bed levels. There is opportunity to install an additional structure above this cluster to assist in trapping upstream mobile sediment as structures 12 & 11 are currently level. The group may consider opportunities to raise the bed level upstream of structures 12 or 11 to assist in stabilising this mobile sediment. Minor maintenance may be required to these existing structures in the placement of rock in scour holes.

Figure 3: Sand beds currently between sites 10 & 11.

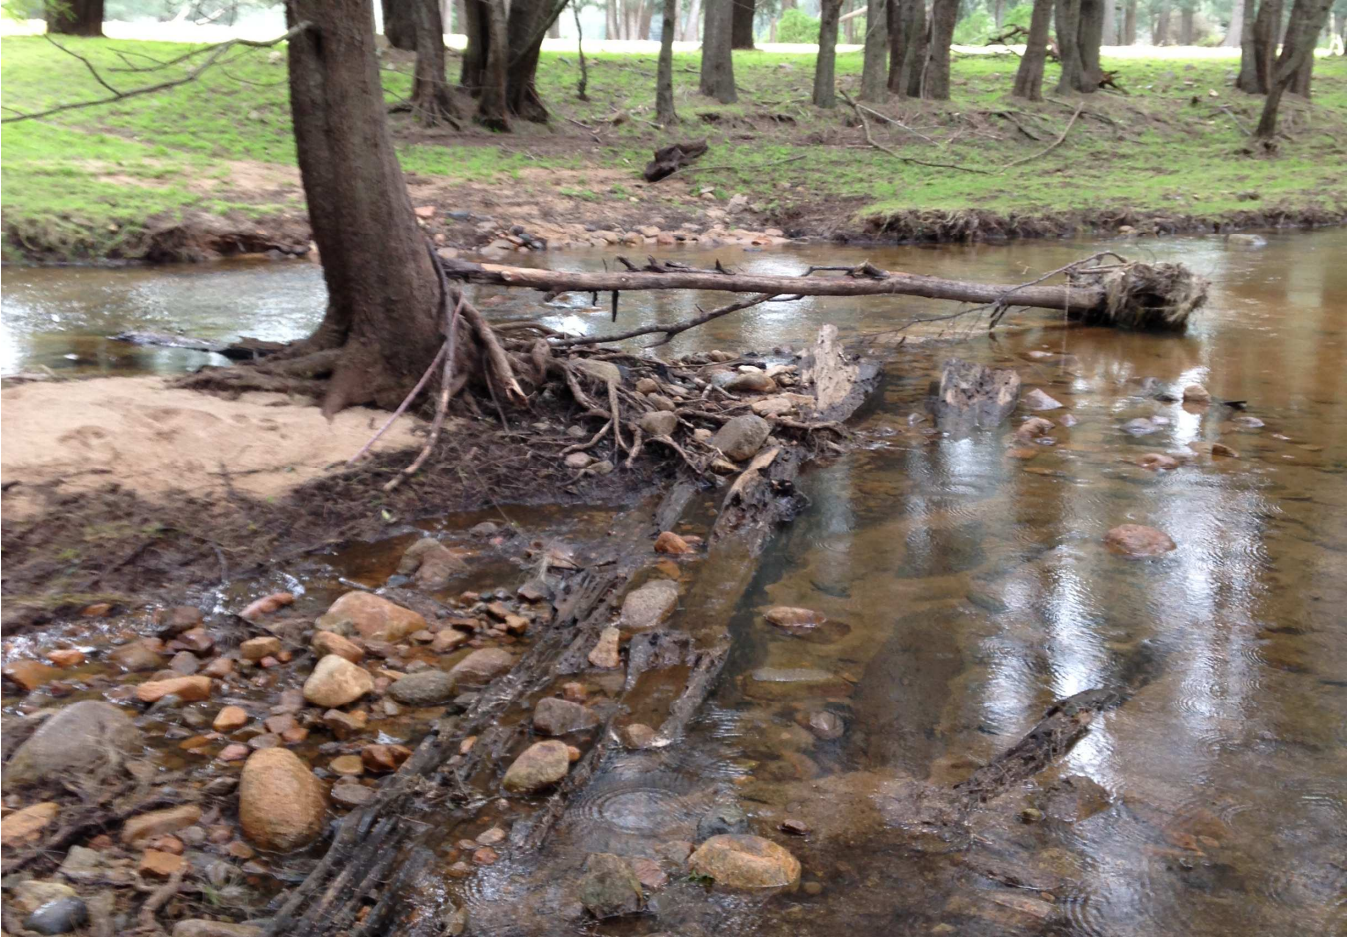
- The log sill at Site 10 has been effective in controlling streambed lowering. There is bed and bank erosion downstream of this site, which may benefit from the previously proposed structure, or may require an additional structure to address this. The log sill at site 10 is showing signs of decay with the top log used in the construction of the structure rotting and partly washed away. The landcare group should consider opportunity to repair this structure via placement of additional logs upstream that may also further raise bed levels to upstream areas.

Figure 4: Log sill at site 10, in need of replacement of upper log/ potential upgrade.

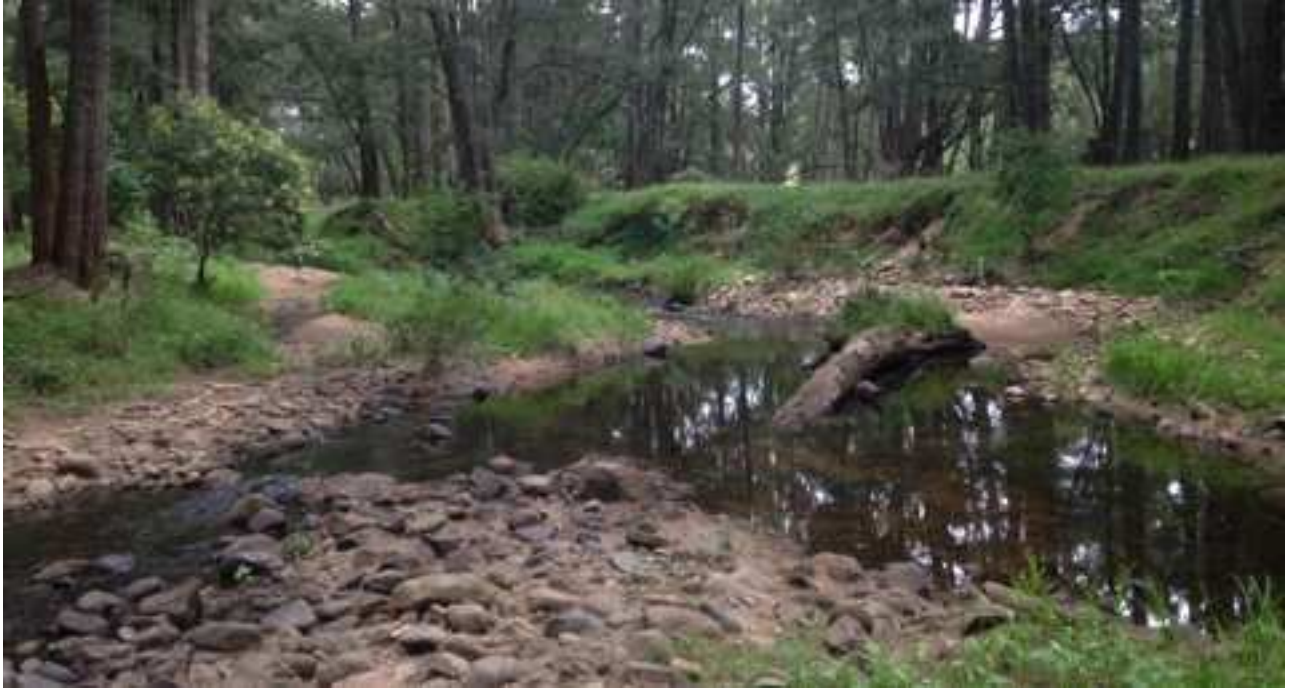
- I have not inspected log sills at sites 9 – 3, however the Landcare group conducted a creek walk in September 2014 and identified potential issues at sites 7 and 8 with active erosion that should be considered. Sites “6” and “8” have not been identified by recent surveys as the structures could not be located and may require additional investigation to locate.
- Log sill at site three is effective in managing streambed lowering upstream of this area, with the long section demonstrating this structure is placed higher than other upstream works. Streambank and bed erosion is occurring downstream of this structure and will need to be assessed.

Figure 5: area below Log sill 3.
