Yanco & Colombo Creek Riparian Vegetation Mapping Baseline Condition Survey 2013

October 2013

Project Name	Yanco Colombo Riparian Vegetation Mapping 2013
Client	Murray Catchment Management Authority
Client Project Manager	Rowan Winsemius
Water Technology Project Manager	Jamie Kaye
Report Authors	Jamie Kaye
Job Number	2761-01
Report Number	R01
Document Name	J2761-01 R01v01 Yanco Colombo Veg

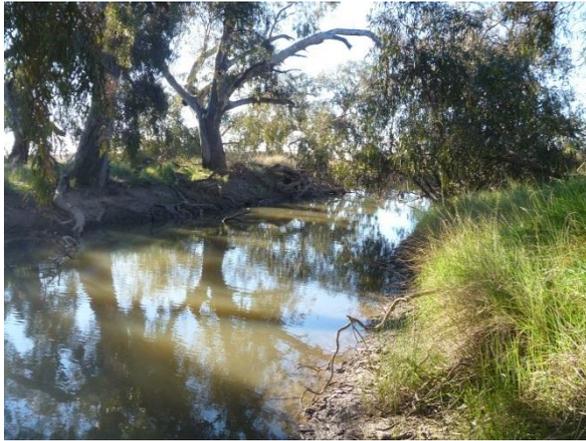
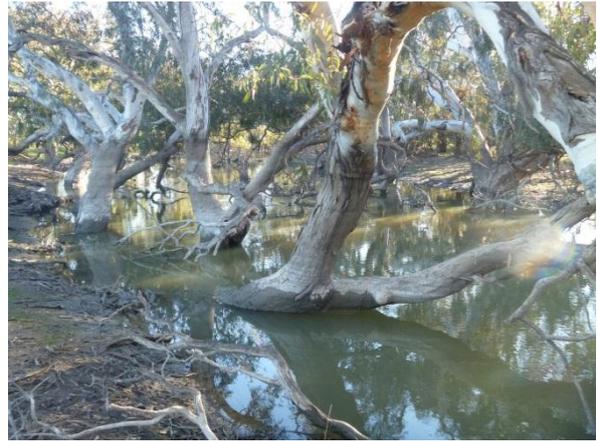
There is a distinct channel shape change that occurs approximately between Sites 25 and 26 in the vicinity of the Berrigan Road. The channel changes from relatively steep upright banks upstream to a flattened bank profile downstream. Figure 10 shows the change in shape between Site 23 and Site 26 located approximately 10km further downstream.

Figure 10 Defined steep banks at Site 23 (left) transitioning to a flatter bank profile at Site 26

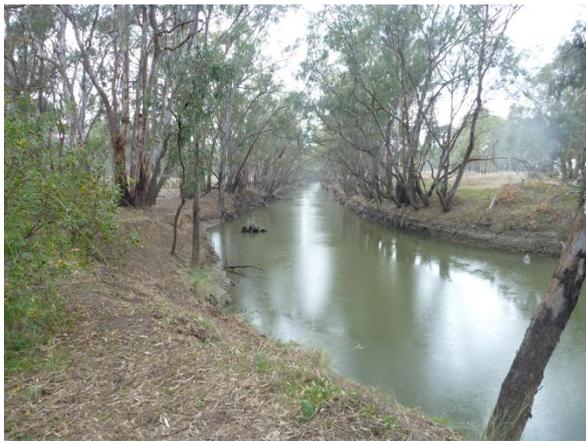
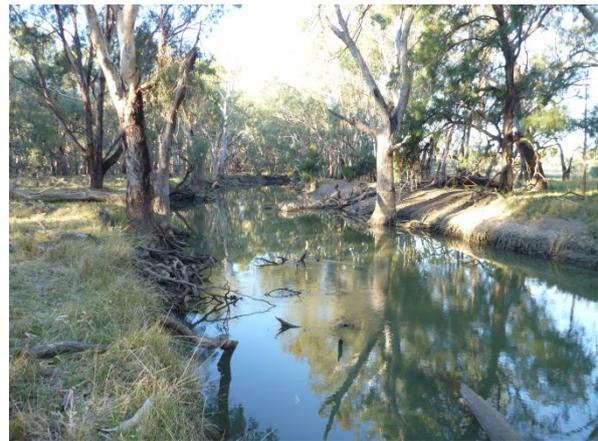
Yanco Creek is a constructed/cut channel most of the section from the Murrumbidgee River offtake to the Sturt Highway (Figure 11). It then enters the natural creek course downstream of the Highway and has relatively steep banks approximately 2m high (Figure 12). Note the relatively young fringing River Red Gums on the constructed channel and the mature individuals along the natural channel bank.

Figure 11 Constructed channel u/s of the Sturt Hwy, and natural channel at Site 63

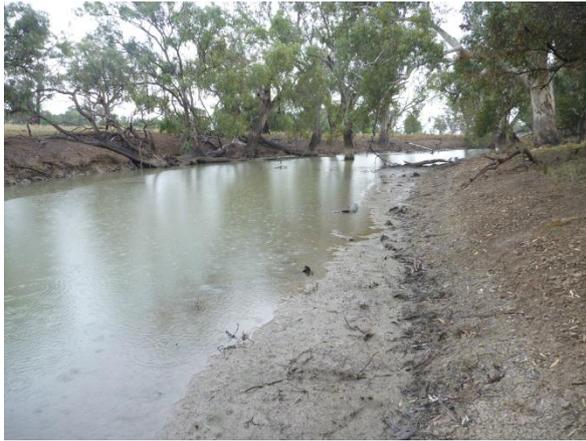
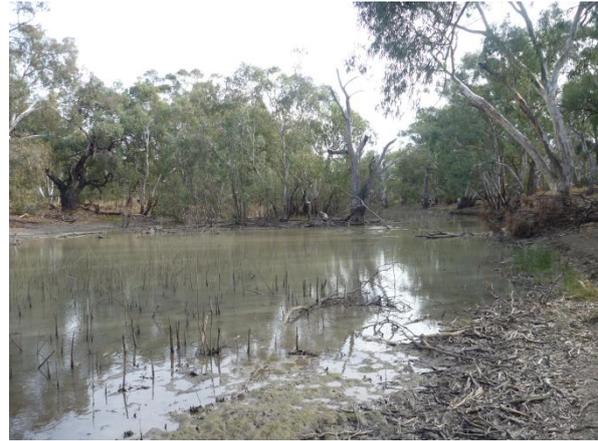
As was the case with the Billabong Creek, the channel broadens and the banks flatten as the creek progresses downstream.

Figure 12 The Yanco Creek Site 72 near Morundah, and Site 102 near Conargo, showing channel shape change with progression downstream

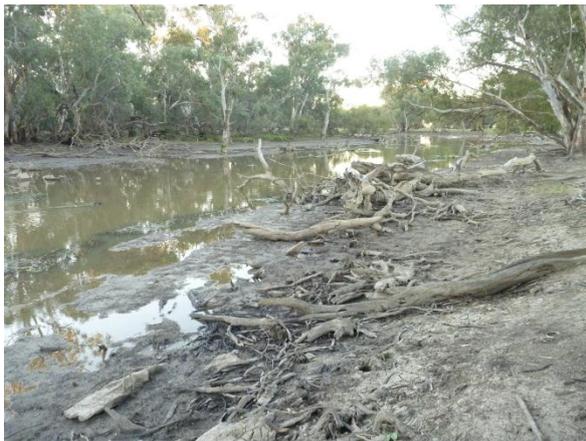
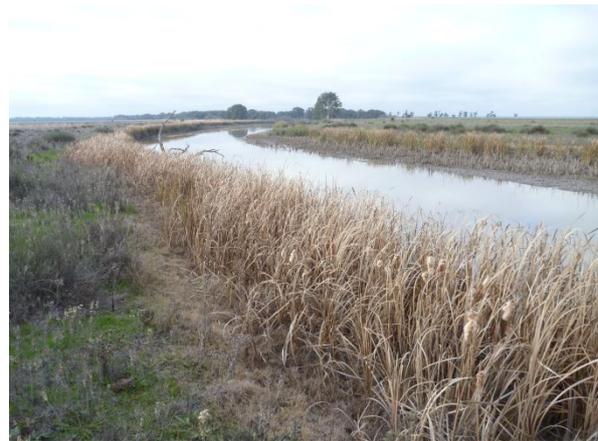
The majority of the Colombo Creek is broad and shallow. Figure 13 shows two sites towards the upstream end of the Colombo Creek that are fairly representative. The sites differ in their relative abundance and lack of adjacent native riparian woodland vegetation, yet the channel width and shape is not dissimilar.

Figure 13 Broad shallow channel shape typical of the Colombo Creek (Sites 106 and 109)

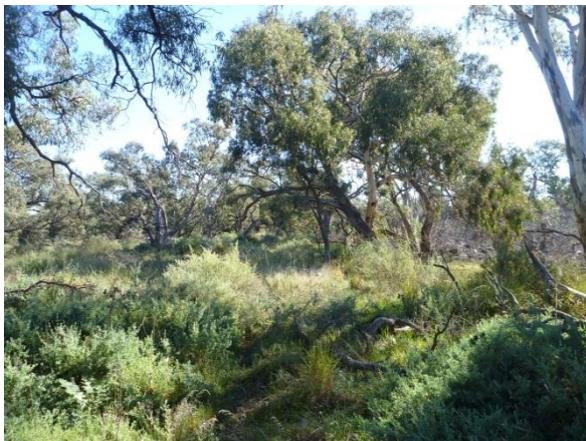
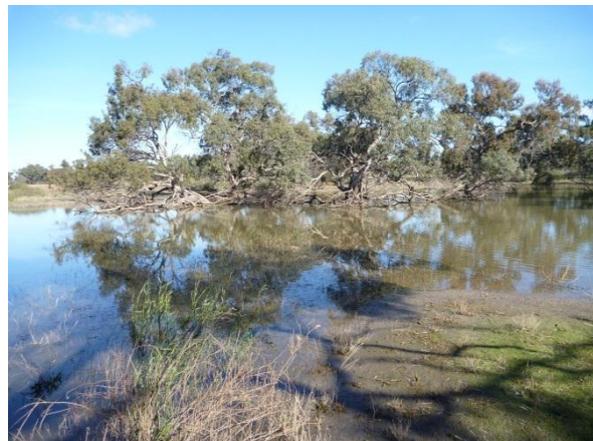
- Nine exotic plant species were identified, which is just above the average number across all sites within the project area (8.6/20).
- A patch of recently poisoned willows was present within the Billabong Creek downstream from the assessment area.

Figure 14 High quality riparian frontage and adjacent wetland near Site 36

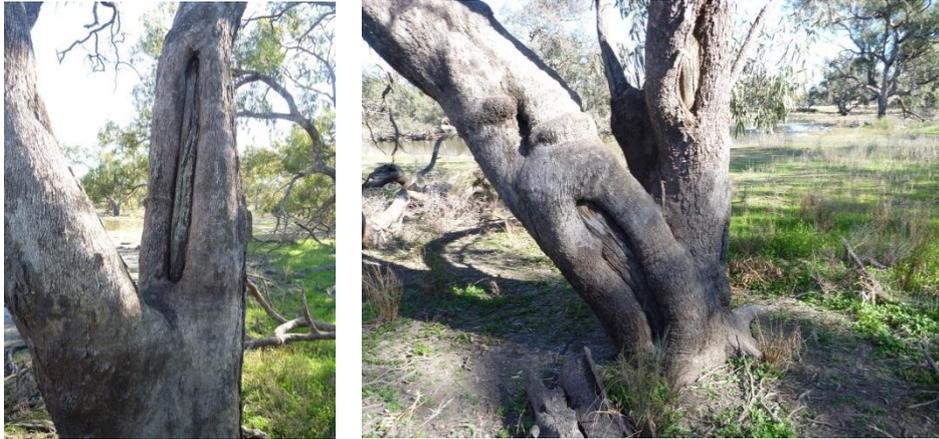
- A number of scarred trees were observed on the edge of the wetland adjacent to the assessment area (see Figure 15).

Figure 15 Scarred Trees on the edge of wetland near Site 36

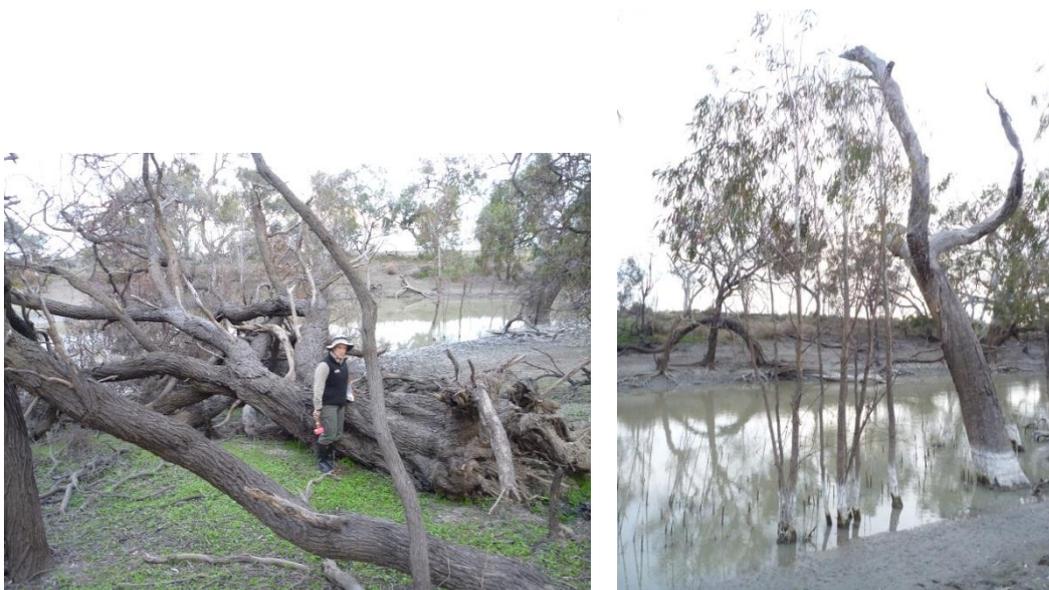
Black Box, River Red Gums and River Cooba were in very poor health or dead in the vicinity of Site 55. Salt was also evident on tree trunks within the Billabong Creek channel. The area needs to be revisited to determine the location of what is presumed to be the input source of saline and possibly agricultural chemical laden water. Figure 16 shows dead river Cooba and very poor health River Red Gums with salt deposits evident at the base of trunks.

Figure 16 Very large dead River Cooba (left) and poor health River Red Gums

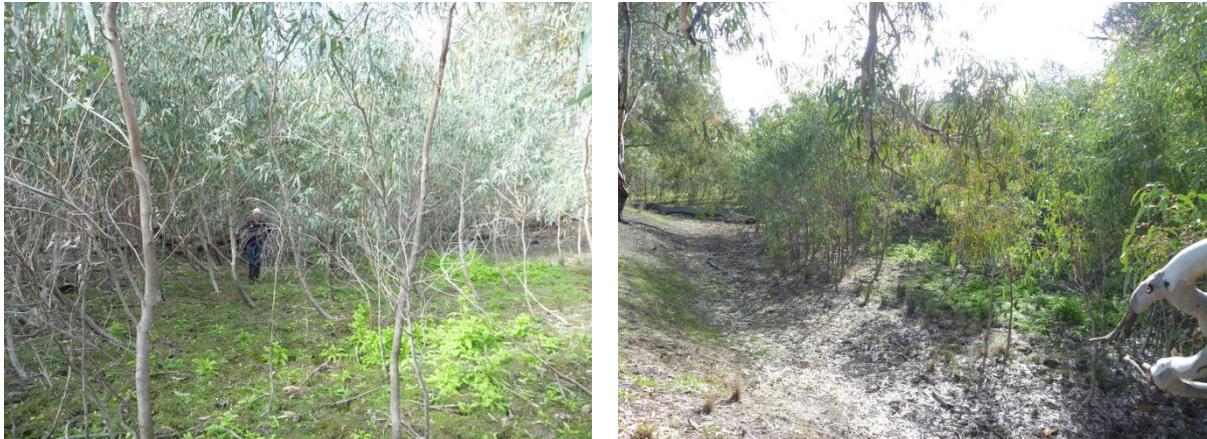
- River Red Gum recruitment into the bed of wetlands and anabranches was evident throughout the Yanco Creek system. The vegetation 'terrestrialisation' of these areas was of concern to some landholders. Many areas have had River Red Gums invade these low lying areas and reach

sufficient height that allowed them to survive the recent high and prolonged flooding events. These trees are now sufficiently tall to withstand significant flooding events without drowning (Figure 17). It is also unlikely that manipulated flows could be delivered for sufficient duration to drown these trees.

Figure 17 River Red Gum invasion (terrestrialisation) of a well-connected Yanco Creek anabranch, Site 79
