# Billabong Creek Riparian Vegetation Mapping 2011-12

September 2012

Project Name	Billabong Creek Riparian Vegetation Mapping 2011-12
Client	Murray Catchment Management Authority
Client Project Manager	Anthony Conallin
Water Technology Project Manager	Jamie Kaye
Report Authors	Jamie Kaye
Job Number	2309-01
Report Number	R01
Document Name	2309-01_R01v03 Billabong Creek Veg

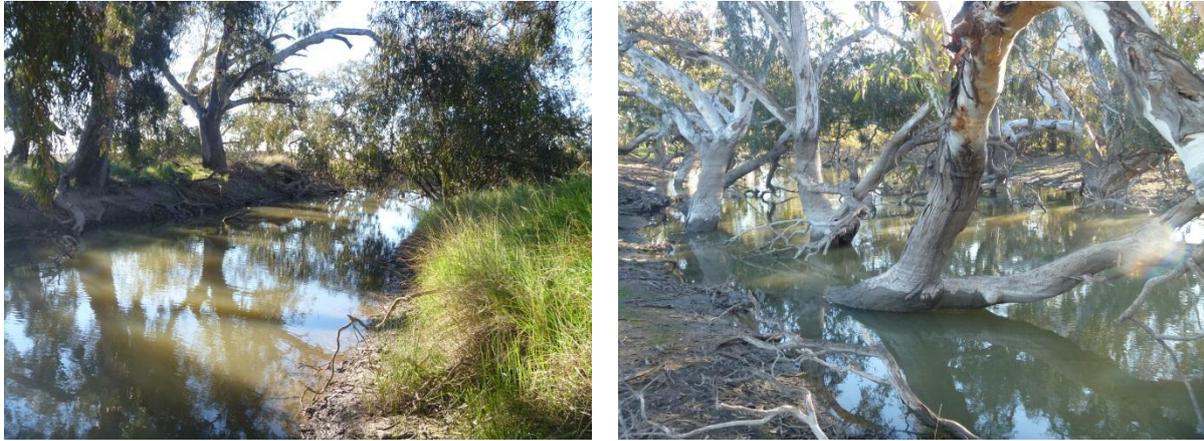
There is a distinct channel shape change that occurs approximately between Sites 25 and 26 in the vicinity of the Berrigan Road. The channel changes from relatively steep upright banks upstream to a flattened bank profile downstream. Figure 10 shows the change in shape between Site 23 and Site 26 located approximately 10km further downstream.

**Figure 10** Defined steep banks at Site 23 (left) transitioning to a flatter bank profile at Site 26

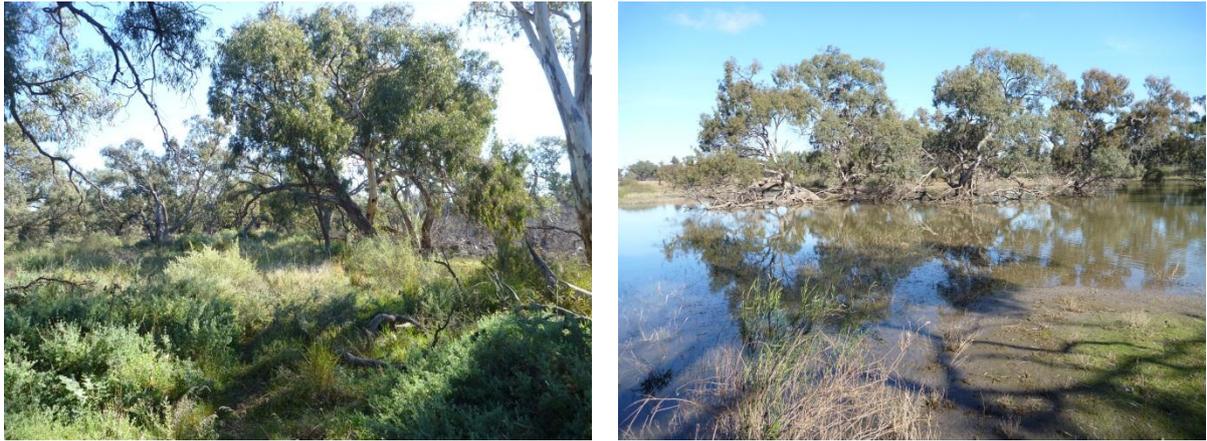
**Figure 11** High quality riparian frontage and adjacent wetland near Site 36

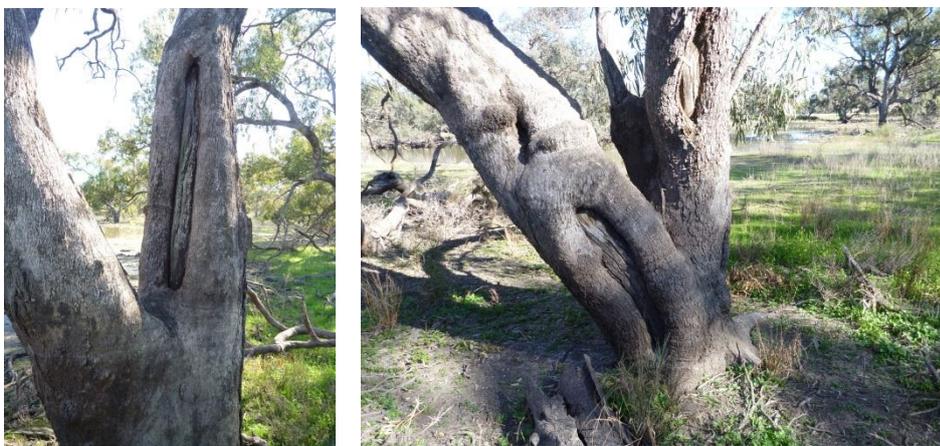
- A number of scarred trees were observed on the edge of the wetland adjacent to the assessment area (see Figure 12).

**Figure 12** Scarred Trees on the edge of wetland near Site 36

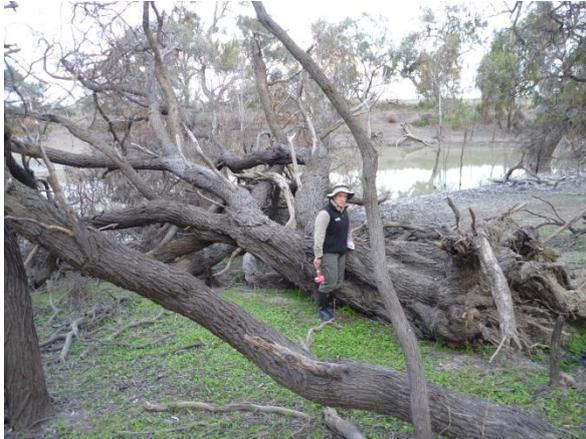
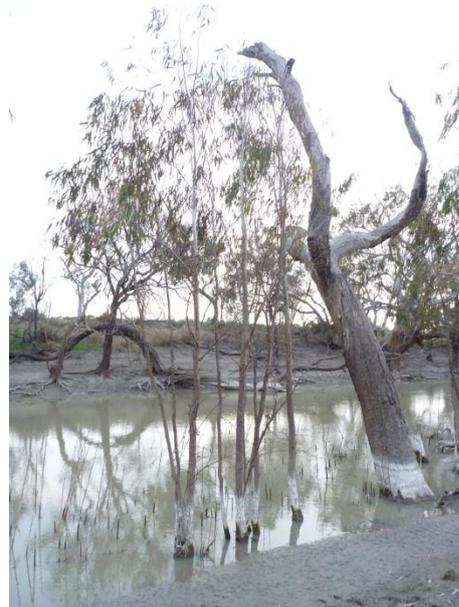
Black Box, River Red Gums and River Cooba were in very poor health or dead in the vicinity of Site 55. Salt was also evident on tree trunks within the Billabong Creek channel. The area needs to be revisited to determine the location of what is presumed to be the input source of saline and possibly agricultural chemical laden water. Figure 13 shows dead river Cooba and very poor health River Red Gums with salt deposits evident at the base of trunks. The site is in the vicinity of the Coleambally Outfall Drain which may be the source.

**Figure 13** Very large dead River Cooba (left) and poor health River Red Gums

- Reach 2 key recommended actions – Weed management.
- Reach 3 key recommended actions – Protect the best frontages.
- Reach 4 key recommended actions – Investigate the cause of poor tree health in the vicinity of Site 55 and continue to monitor tree health to inform environmental flow recommendations.
