# Wanganella Swamp

## 2019/20 Watering Event

### Inundation Extent & Vegetation Response

Report Title: Wanganella Swamp 2019/20 Watering Event; Extent of Inundation and Vegetation Response (unpublished)

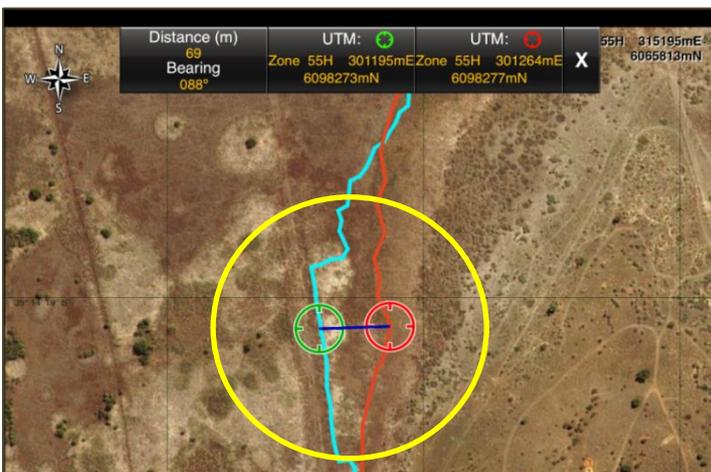
Figure 5: iPad screenshot showing a discrepancy circled in yellow of 70m between the satellite based extent in red and the on-ground recorded extent in blue (GPS MotionX).

Although the satellite based extent was relatively accurate in some areas it proved to be inaccurate by up to 70m in the flatter areas of the western swamp. Figure 5 below shows an iPad screenshot with both the satellite derived and the field recorded extents. Due to the inaccuracy of the satellite derived extent the entire extent was recorded in the field. Field recorded files were uploaded to a GIS program to map and calculate the maximum extent of inundation.

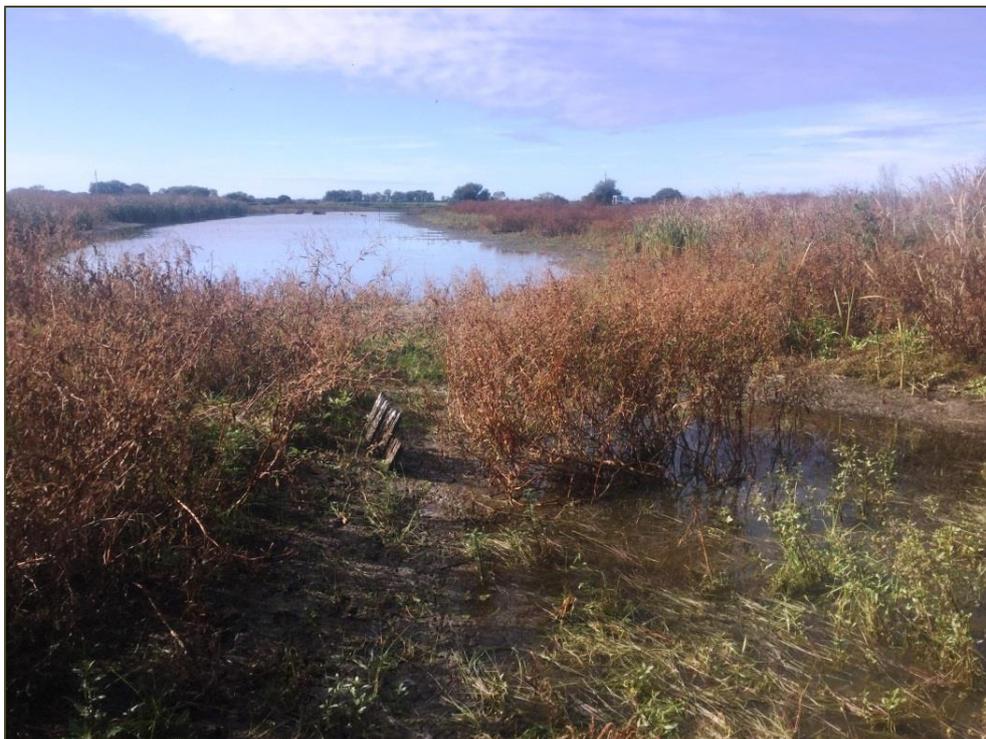
Figure 17: View east/upstream of the southern Eight Mile Ck channel, showing the old block bank.

Flows to the western swamp via Eight Mile Creek were predominantly via the northern channel. An old earth bank 300m west of the highway appeared to have significantly impeded flows within the southern channel. The inundation map in Figure 16 below shows the limited flooding that occurred downstream of the old block bank.

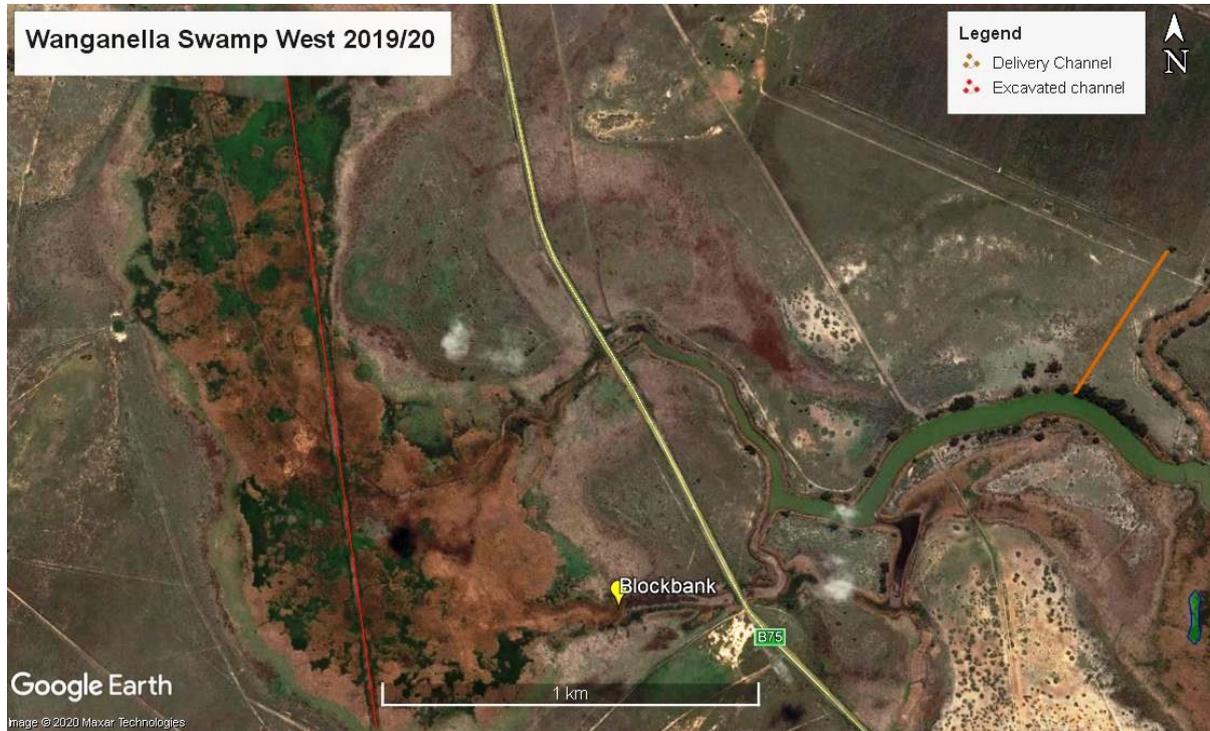
Figure 18: Map indicating the location of the excavated channel within the western swamp (Google Earth).

The excavated channel which runs south to north within the western swamp heavily influenced the extent and duration of inundation. Satellite imagery indicated flows via the northern Eight Mile Creek channel predominantly remained within channel with the extent largely resulting from backfilling from the downstream regulator. The excavated channel and associated spoil bank prevent the flood waters extending further east (see Figures 18 & 19).

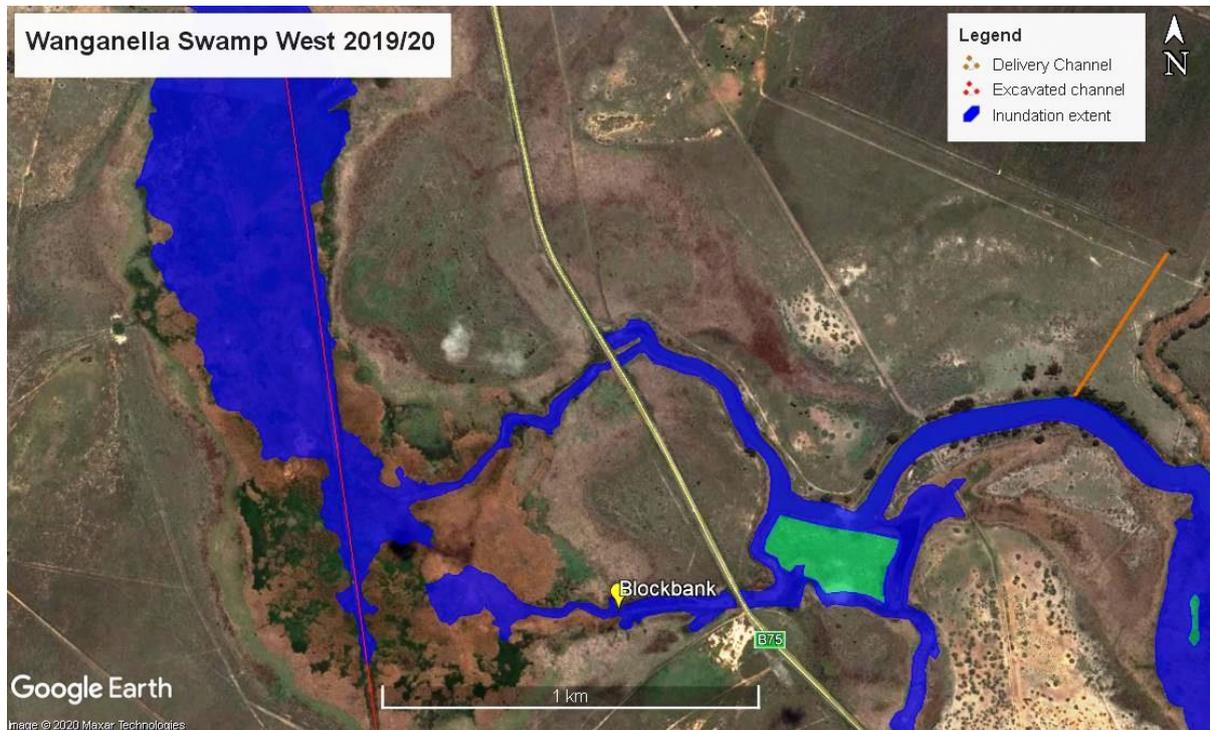
Figure 19: Map indicating the limited flooding east of the excavated channel marked with a red line (Google Earth).

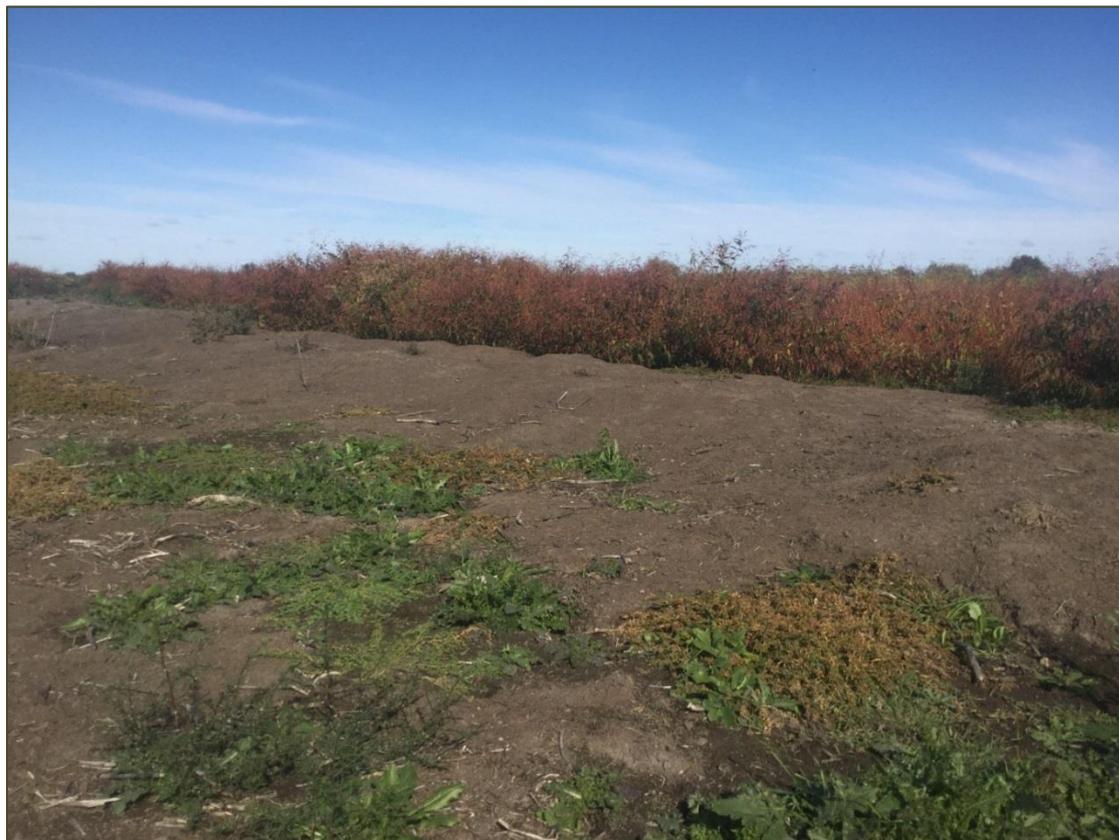
Figure 20: Excavated channel spoil prevent inundation to the east.

Figure 20 below shows the spoil bank associated with the excavated channel with wetland vegetation response to flood inundation west of the excavated channel and the dry soil to the east with no inundation or wetland vegetation response.
