Yanco & Colombo Creek Riparian Vegetation Mapping Baseline Condition Survey 2013

October 2013

Project Name	Yanco Colombo Riparian Vegetation Mapping 2013
Client	Murray Catchment Management Authority
Client Project Manager	Rowan Winsemius
Water Technology Project Manager	Jamie Kaye
Report Authors	Jamie Kaye
Job Number	2761-01
Report Number	R01
Document Name	J2761-01 R01v01 Yanco Colombo Veg

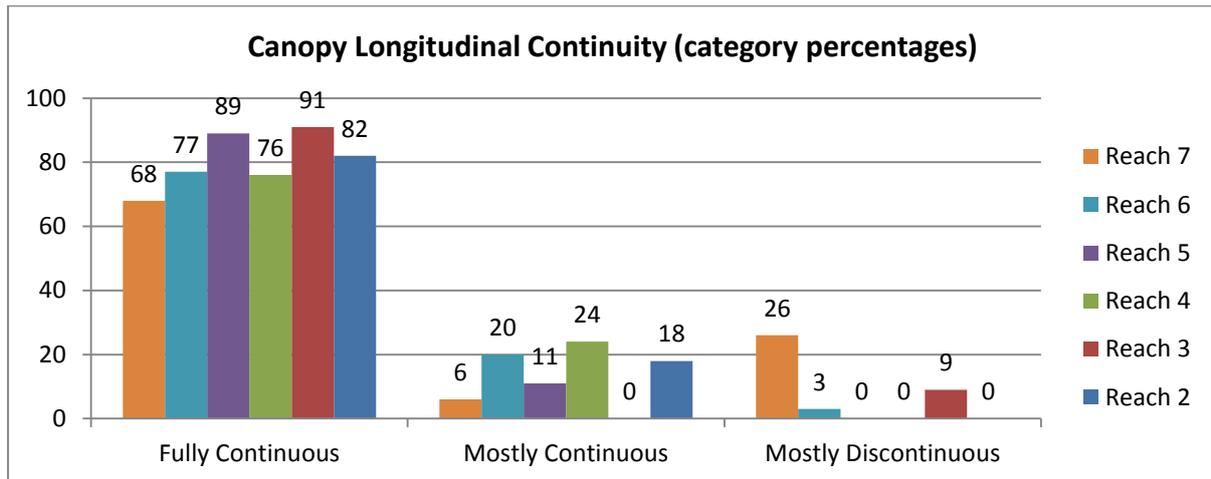
Figure 4 Reach percentage of sites within each continuity category

Longitudinal Continuity of woody vegetation along the bank, principally canopy cover, was assessed at each of the 124, 100m long sites. Canopy continuity along the top of bank was observed as being either Fully Continuous (i.e. no breaks in canopy of more than 10m long within the 100m site length), Mostly Continuous (i.e. some breaks of more than 10m but the majority of frontage vegetated), or Mostly Discontinuous (i.e. breaks in continuity, greater than 10m long, form the majority of the frontage). Figure 4 indicates that the majority of assessed sites have fully continuous vegetation. The anomalous result is the high percentage (5/19 sites, 26%) of mostly discontinuous sites within the Colombo Reach 7. All of these discontinuous sites are located in the middle sections of the Colombo Creek.

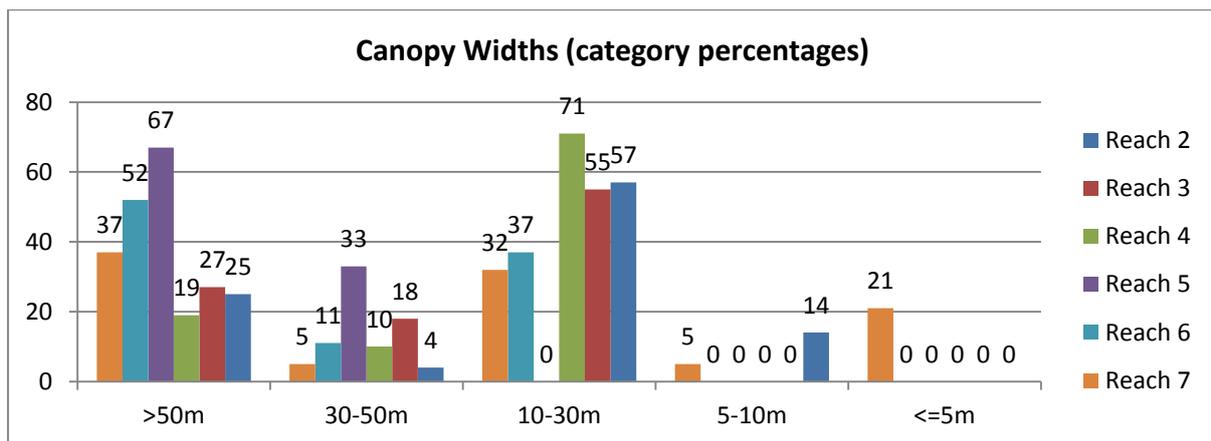
Figure 5 Reach percentage of sites within each canopy width category

The width categories indicate that the majority of Billabong Creek sites (Reaches 2-4) were in the 10-30m wide, whereas the majority of Yanco and Colombo Creek sites (Reaches 5-7) were in the >50m wide category; this is despite Reach 7 having a high percentage of mostly discontinuous sites.

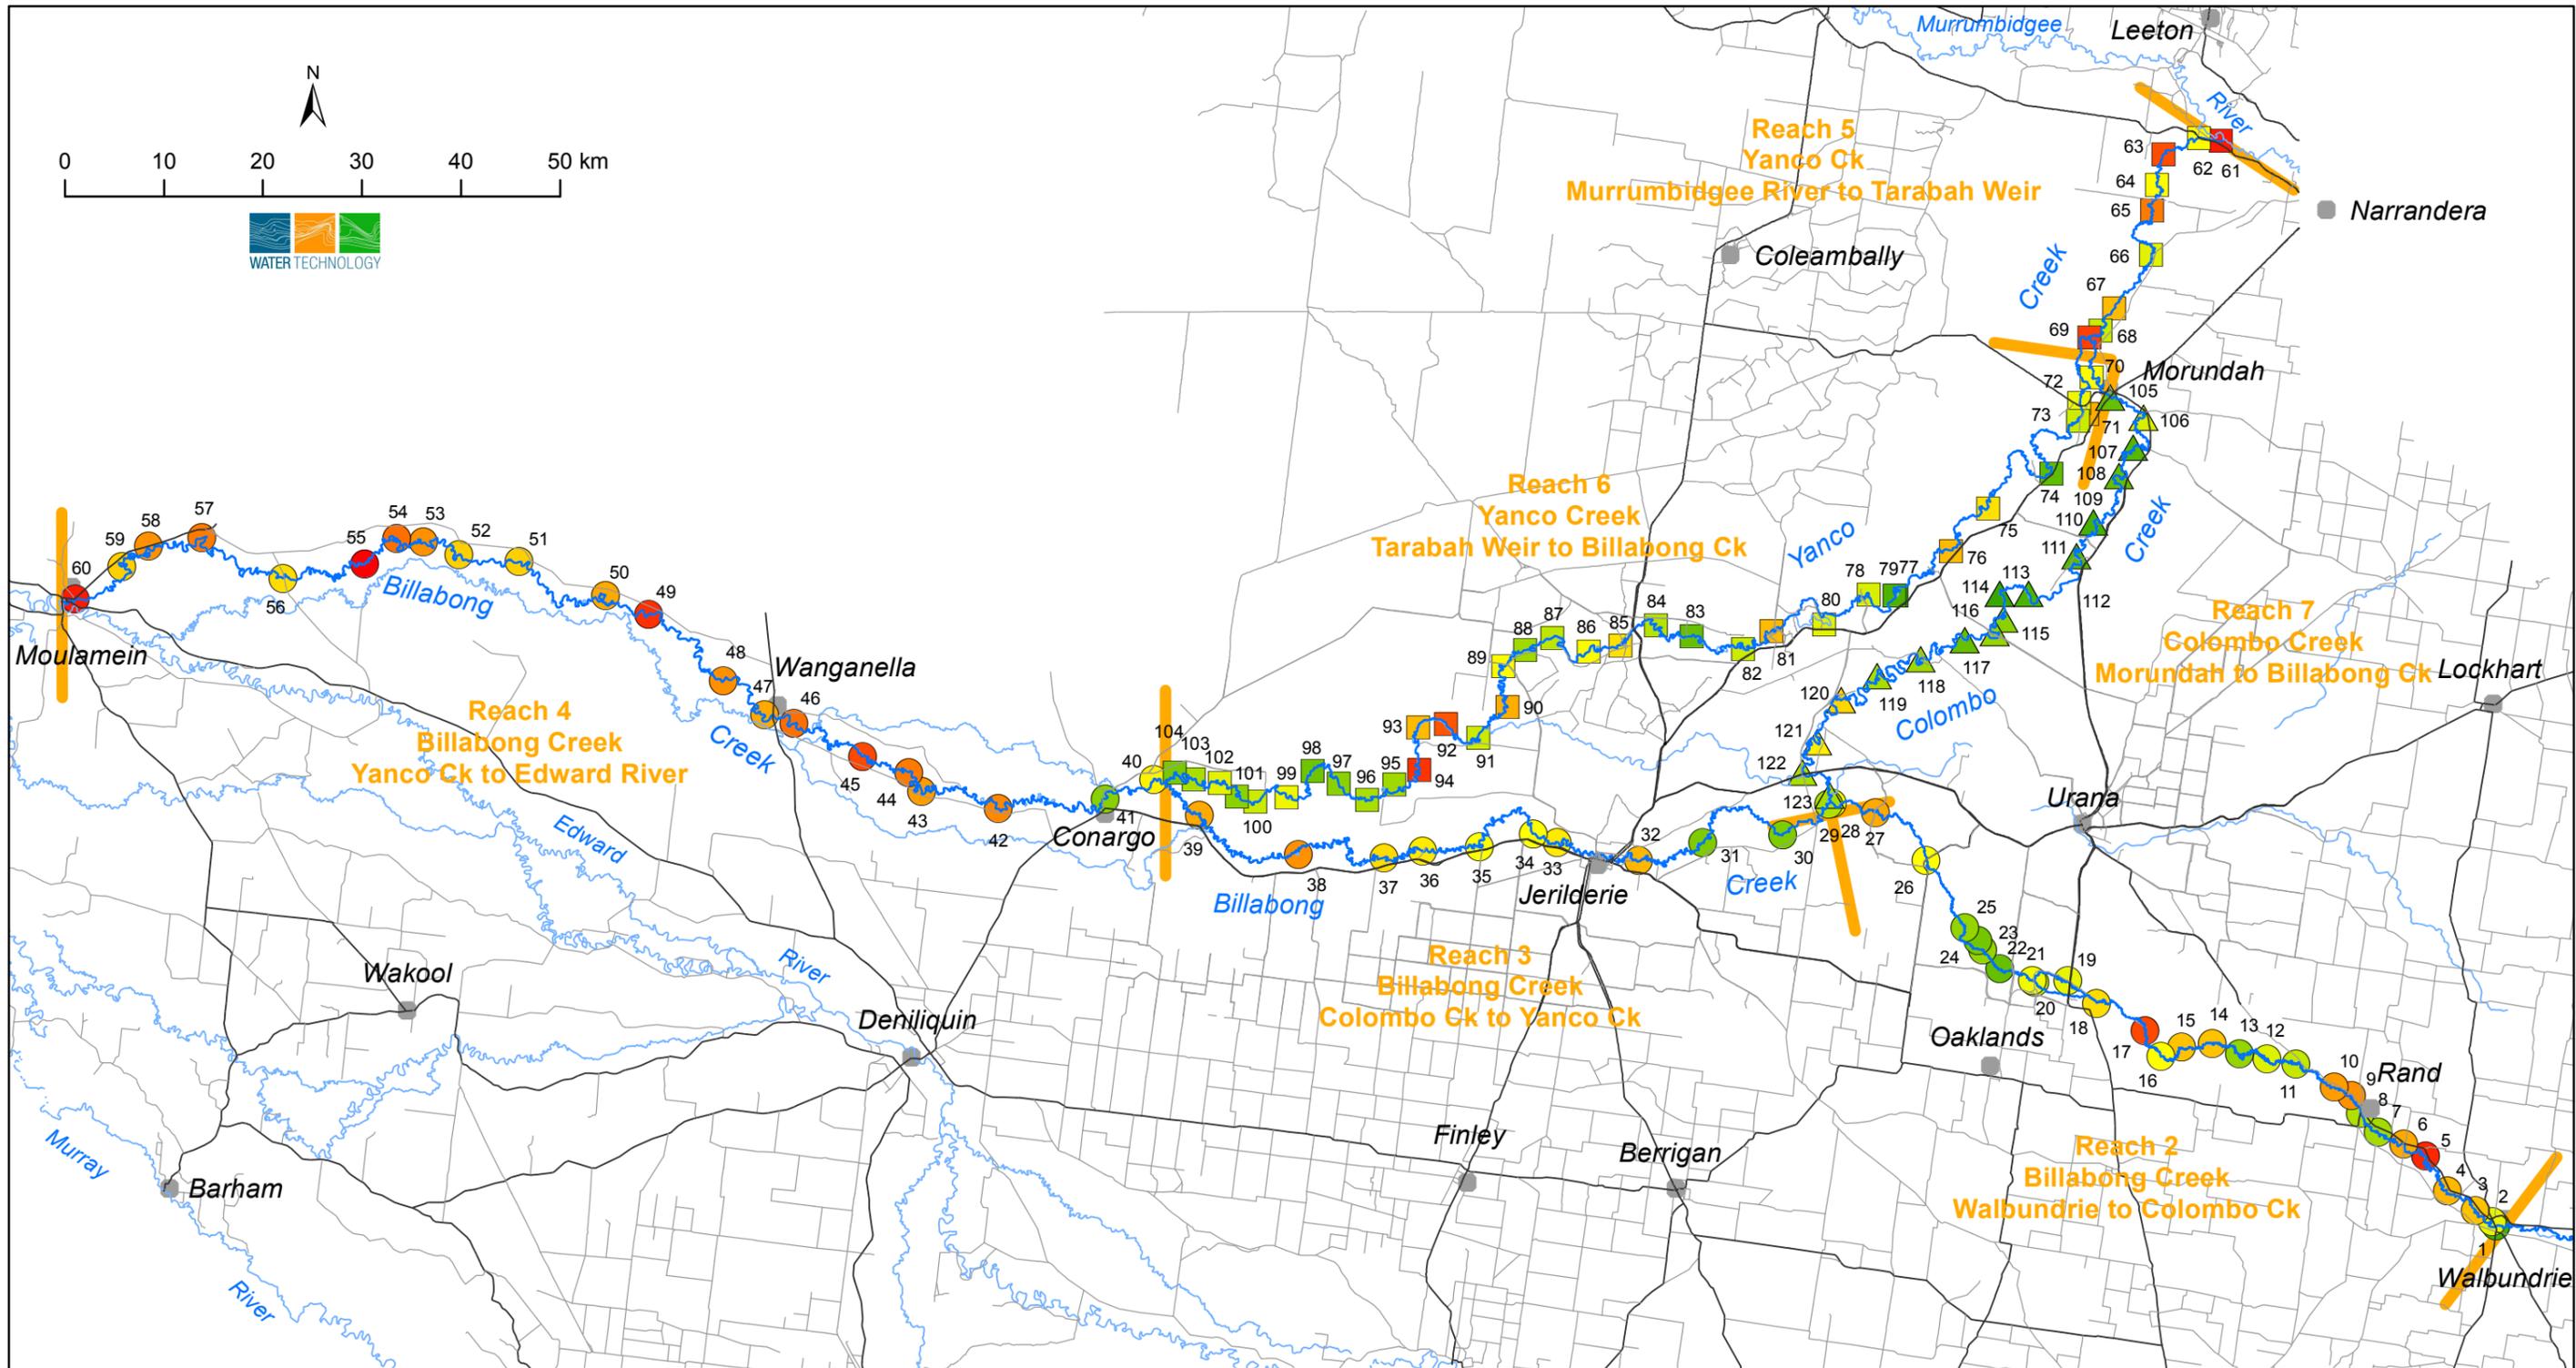
Reach 7 has the highest Canopy Health average score. Although Reach 7 shows poor Width and Continuity scores, the trees that are present are in relatively good health. This is possibly due to there often being a narrow strip of trees at the top of bank which have permanent access to water in the creek, therefore maintaining vigour during the recent drought period.

Reach 4 has the lowest Canopy Health average while Reach 5 has lower than expected Canopy Health given the high scores for Habitat Quality and Riparian & Instream Health.

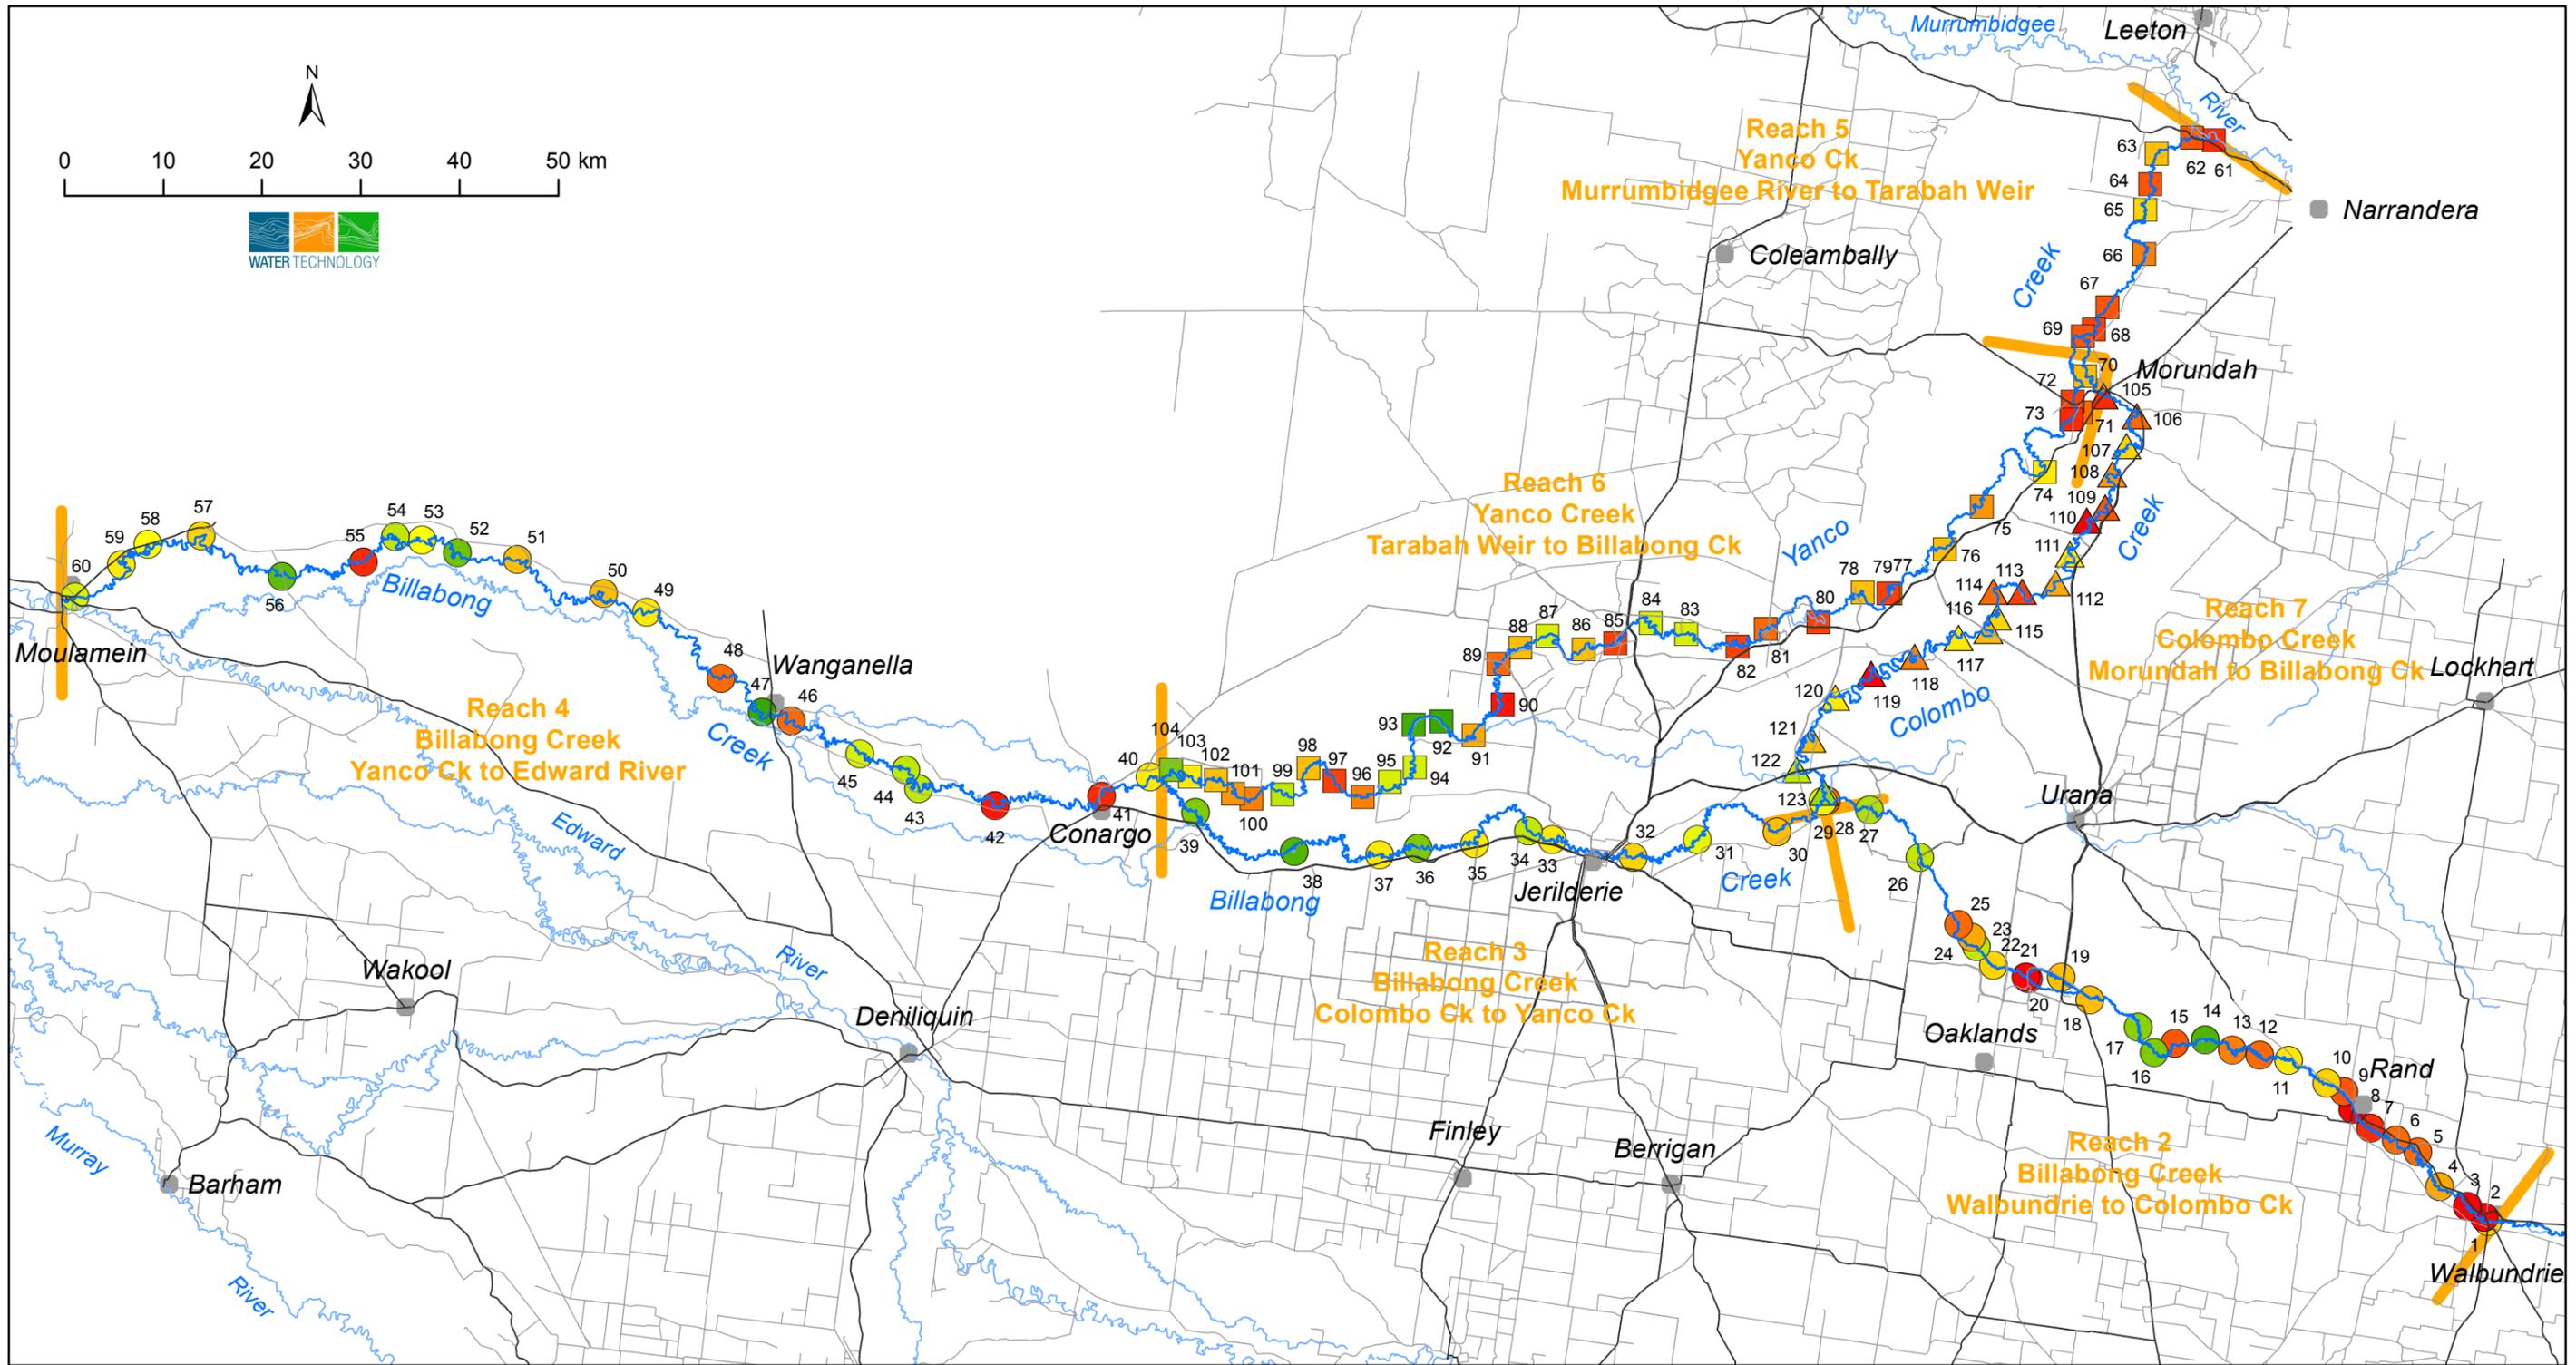
Figure 8

Weed cover percentages are presented graphically in Figure 8. The following comments have been drawn from the Weed Cover results:

- The Billabong Creek Reaches 3 and 4 show considerably less weed cover than the other reaches. Reach 3 has the lowest percentage weed cover, the lowest number of weed species per site, and the highest number of native species per site.
- The upper Yanco Reach 5 has the highest exotic understorey cover and also has the highest native understorey cover. This indicates that there is little bare ground and the inter-tussock spaces are occupied by exotic herbs and grasses.
- The weed cover percentages tend to correlate with the average number of exotic species identified within each Reach as graphed on Figure 3.
- Sites 2, 3, and 21 within Reach 2, and sites 110 and 119 within Reach 7, have high weed cover at 85%.
- Sites 47 (Wanganella Reserve) and 92 (recently burnt and little ground cover at all) had low weed cover at 1%.

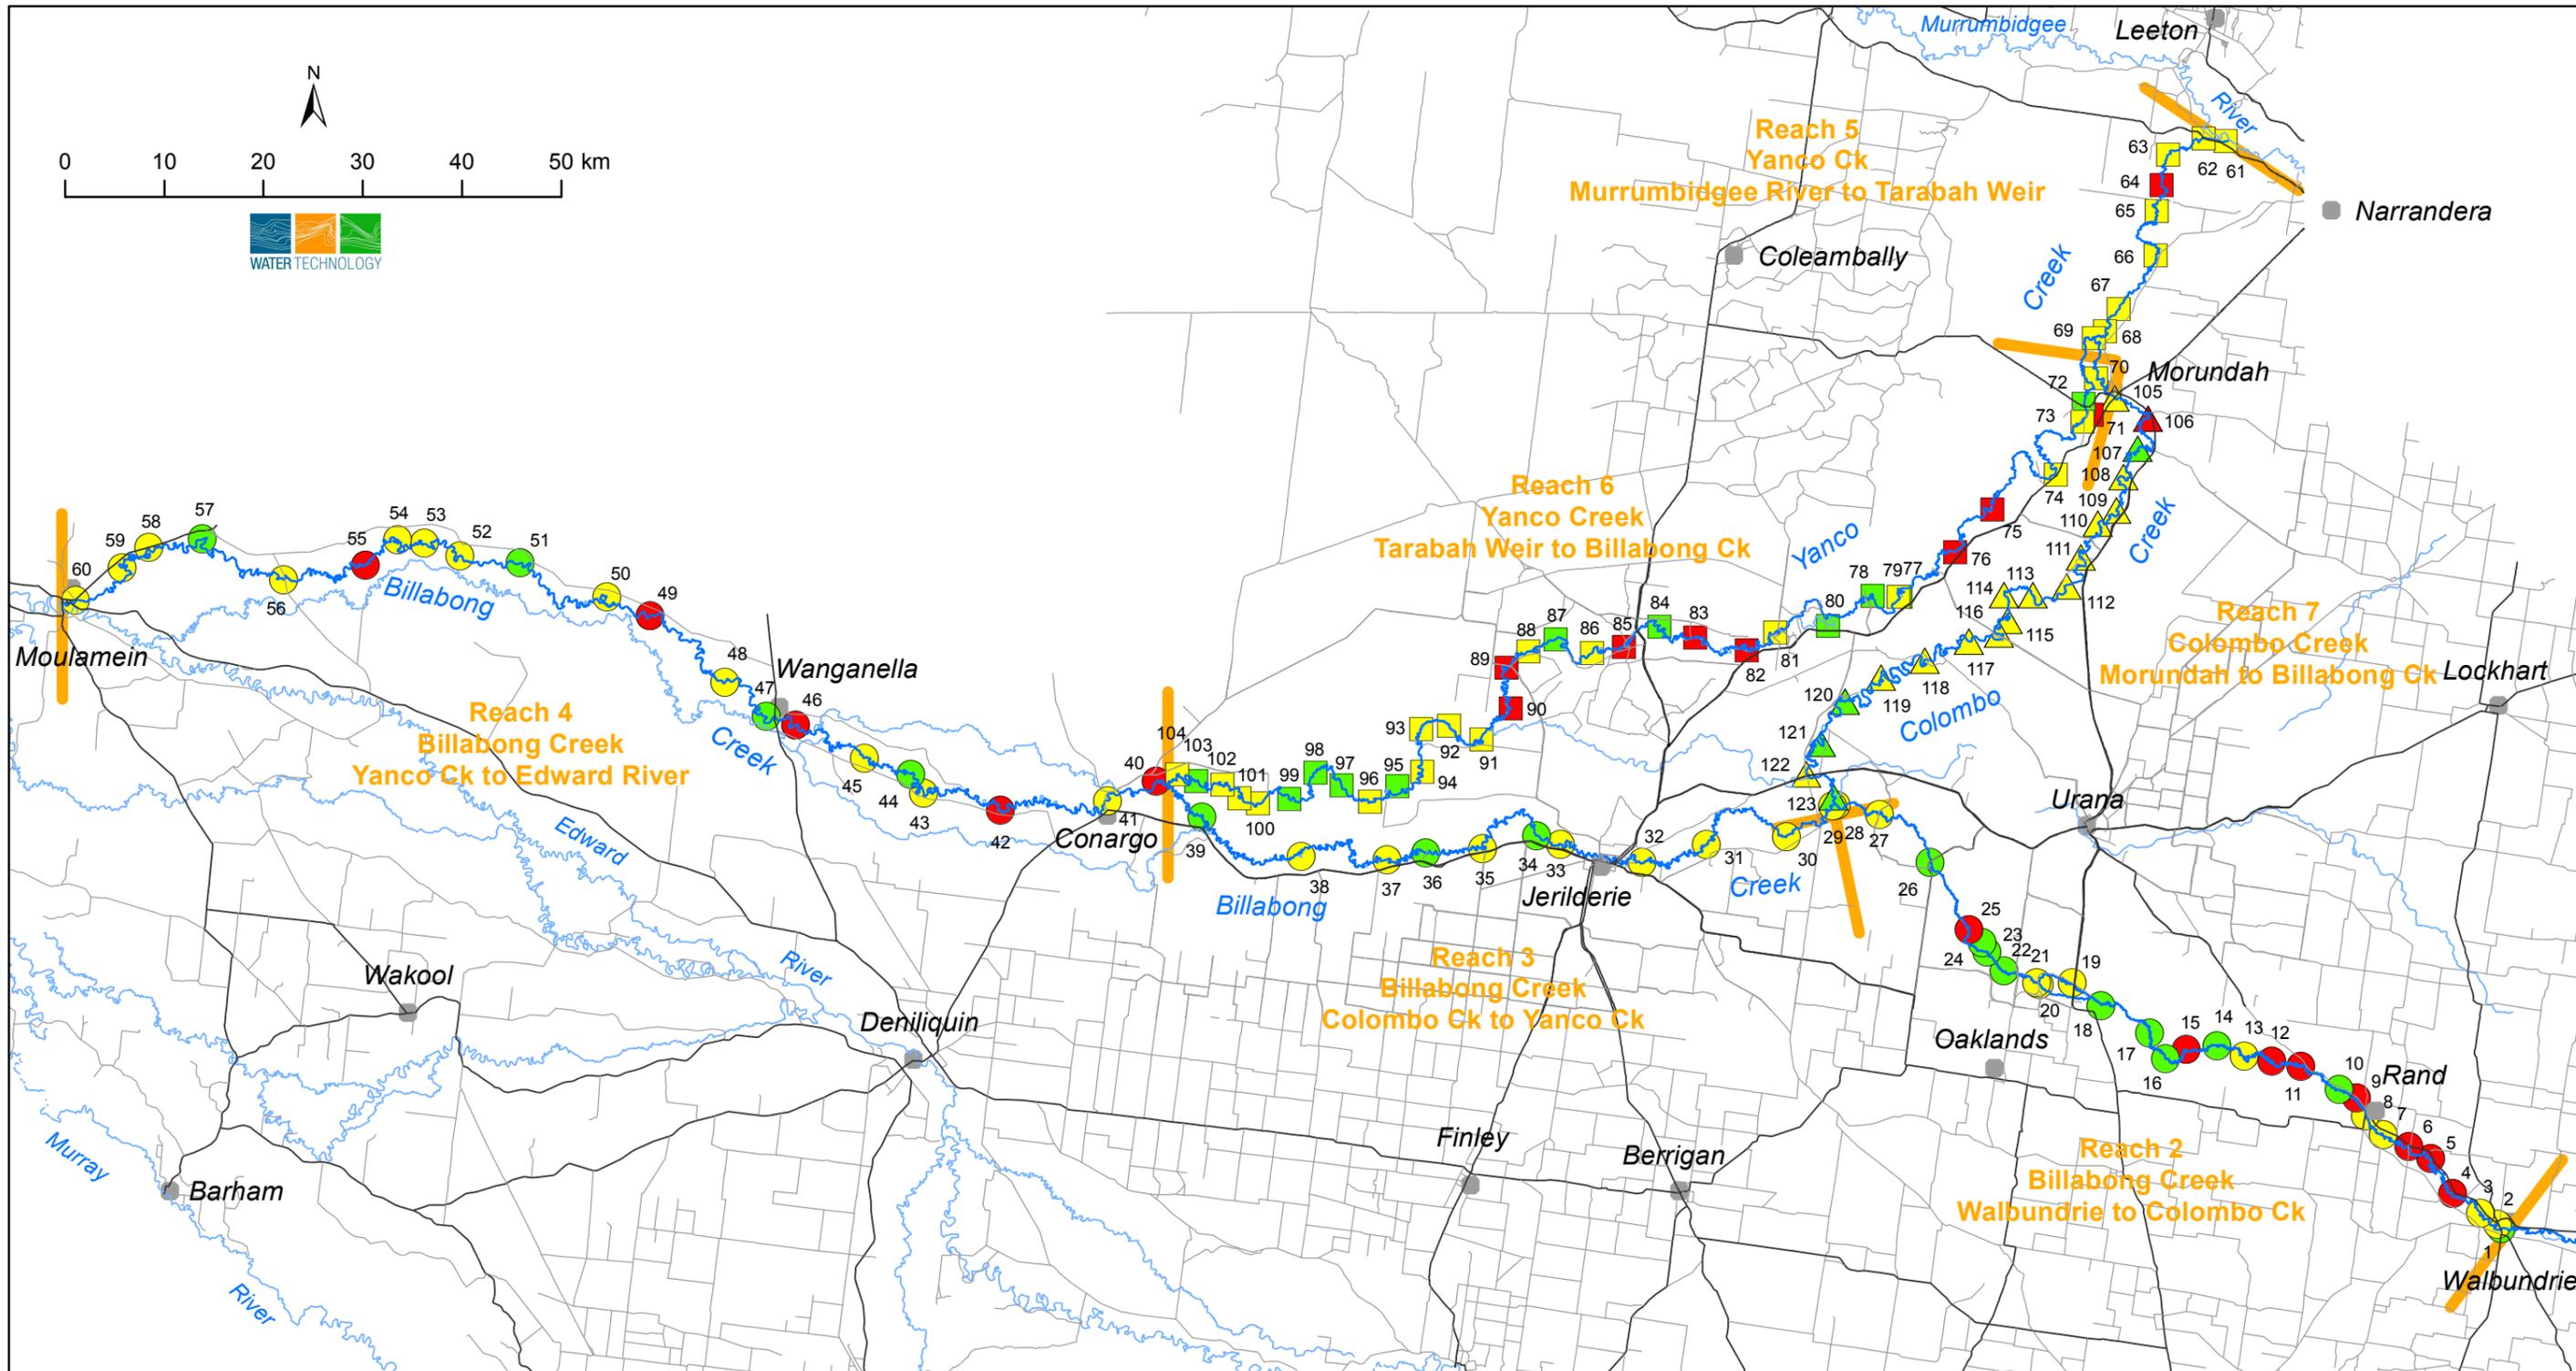
A review of Condition Trajectory results by reach shows the following trends:

- Reaches 2 and 6 have high percentages of improving sites, but also have high percentages of declining sites.
- Reach 3 had no declining sites.
- Reach 5 has no improving sites and most sites were assessed as having a stable Condition Trajectory.
