# Billabong Creek Riparian Vegetation Mapping 2011-12

September 2012

Project Name	Billabong Creek Riparian Vegetation Mapping 2011-12
Client	Murray Catchment Management Authority
Client Project Manager	Anthony Conallin
Water Technology Project Manager	Jamie Kaye
Report Authors	Jamie Kaye
Job Number	2309-01
Report Number	R01
Document Name	2309-01_R01v03 Billabong Creek Veg

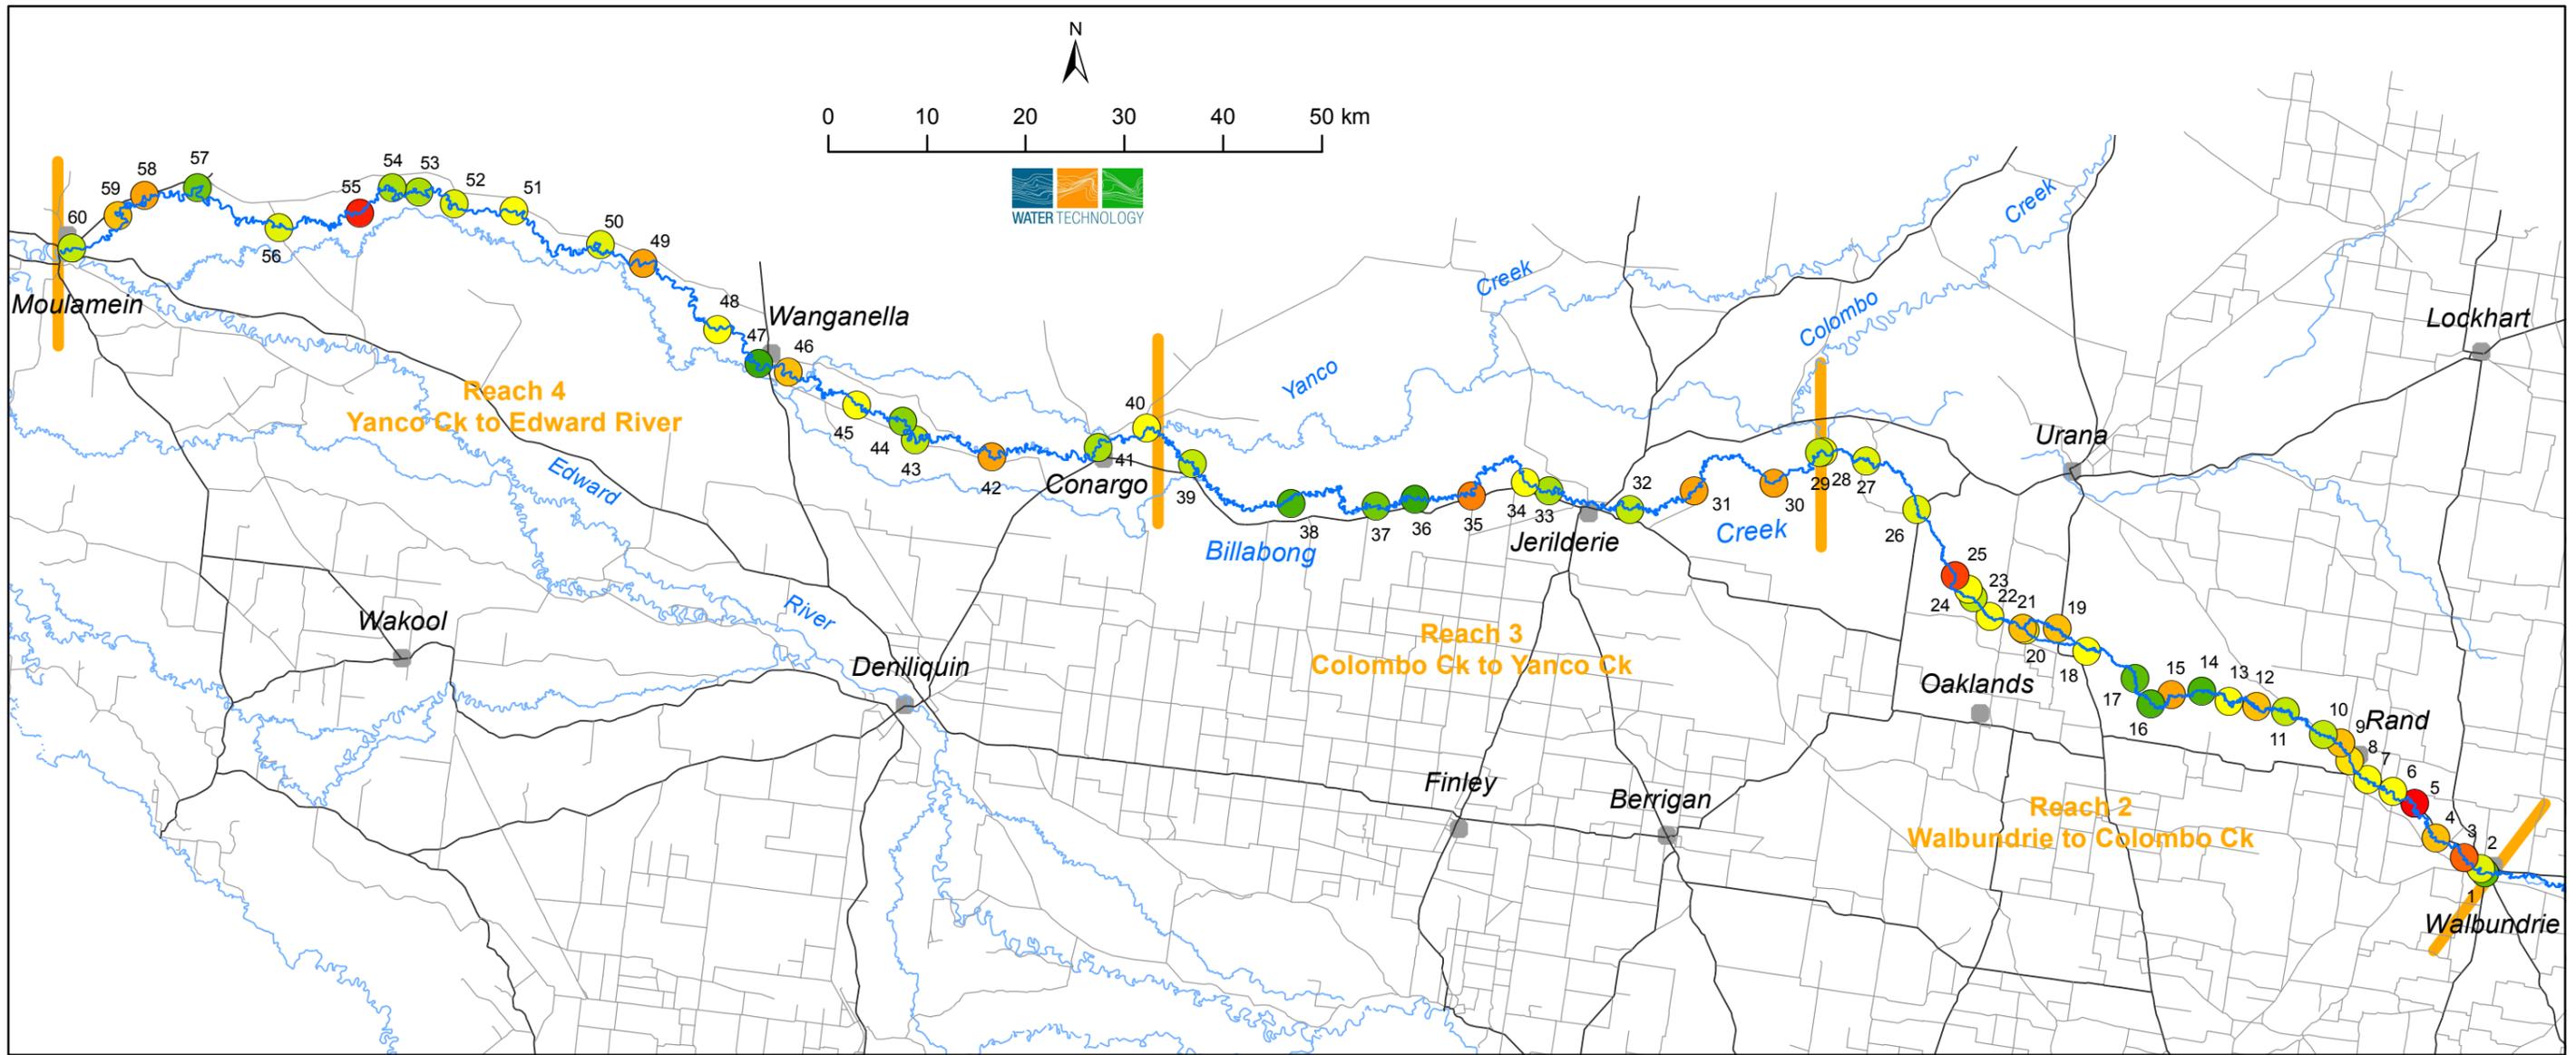
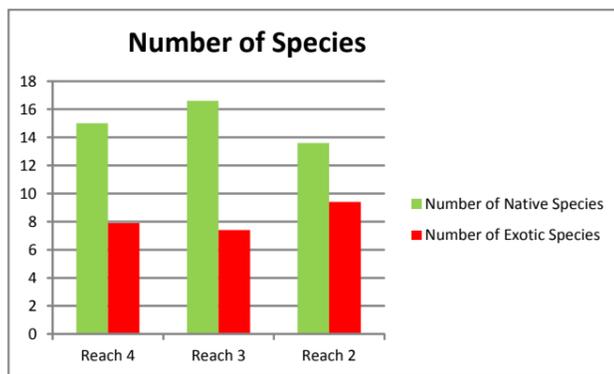
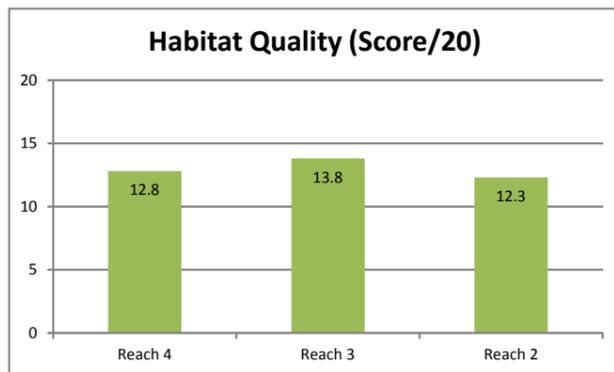
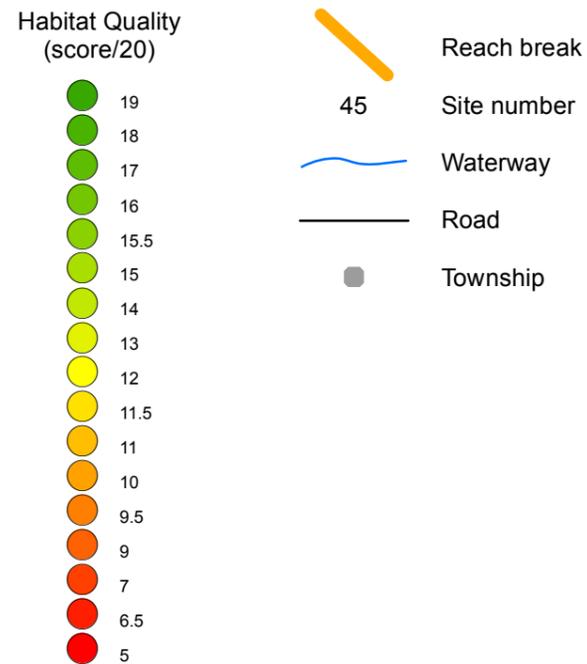
Figure 3

The total score out of 20 for each site has been displayed graphically in Figure 3. The mapping indicates that the condition of frontages is quite variable and that there are no very strong condition trends across the project area. The Habitat Quality results do not appear to be strongly affected by flow regulation as the overall condition of each reach is similar (see the habitat quality score graph on Figure 3). That said, component scores within the method do indicate some differences between reaches. The stronger differences in component scores are as follows:

Although not part of the Habitat Quality assessment, the native and exotic species count averages for each reach has been graphed and displayed on Figure 3. This graph shows a clear distinction with Reach 3 having the highest average number of native species, and the lowest average number of weed species. Reach 4 also shows a higher native species diversity and lower number of weed species than Reach 2.

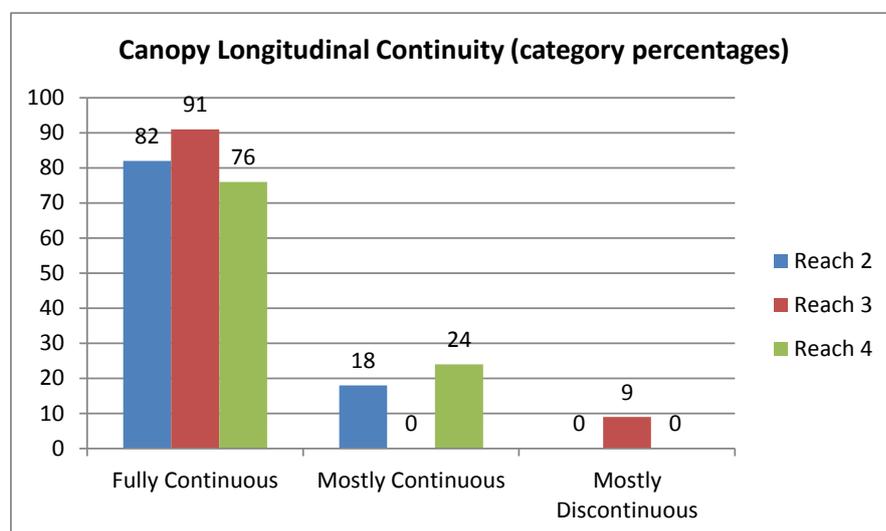
**Figure 5** Reach percentage of sites within each continuity category

Longitudinal Continuity of woody vegetation along the bank, principally canopy cover, was assessed at each of the 60, 100m long sites. Canopy continuity along the top of bank was observed as being either Fully Continuous (i.e. no breaks in canopy of more than 10m long within the 100m site length), Mostly Continuous (i.e. some breaks of more than 10m but the majority of frontage vegetated), or Mostly Discontinuous (i.e. breaks in continuity, greater than 10m long, form the majority of the frontage). Figure 5 indicates that the majority of assessed sites have fully continuous vegetation. Reach 2 and Reach 4 sites had a number of sites with discontinuities (18% and 24% of sites respectively) and only one site in the project area (within Reach 2) was assessed with mostly discontinuous canopy cover.

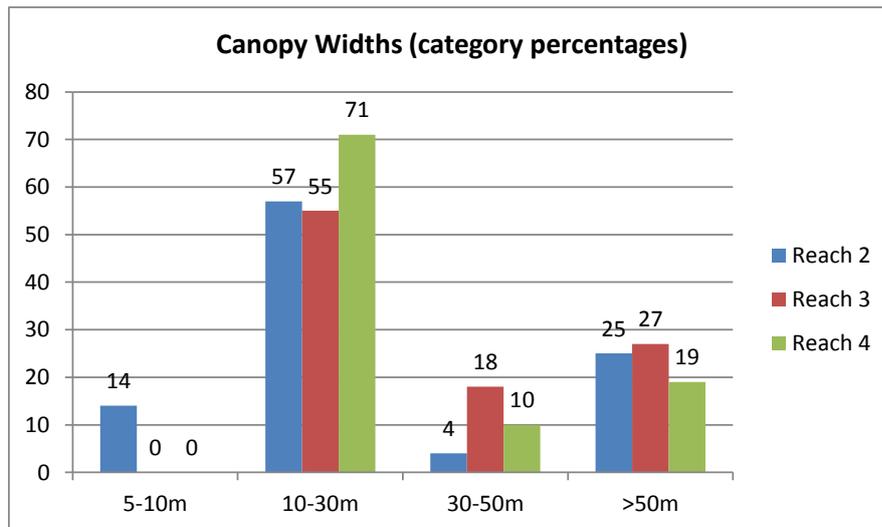
**Figure 6 Reach percentage of sites within each canopy width category**

This graph indicates that the majority of sites across the project area have a canopy width of 10-30 metres wide. It also shows that a good proportion of sites have very wide canopy width that exceeds 50 metres. The graph also shows that a number of sites (14%, 4/28 sites) within Reach 2 have a relatively narrow canopy width less than 10m.

It is appropriate to note that Reaches 3 and 4 have a flattened bank profile (see Section 4.2) compared to the majority of Reach 2. The flattened bank profile meant that the top of bank, and therefore edge of floodplain, was often approximately 20 metres from the edge of the water. Since the majority of assessment sites within Reaches 3 and 4 had Canopy Widths less than 30m (55% and 71% respectively), this indicates that very often canopy trees did not extend onto the floodplain but were effectively contained within the creek channel.

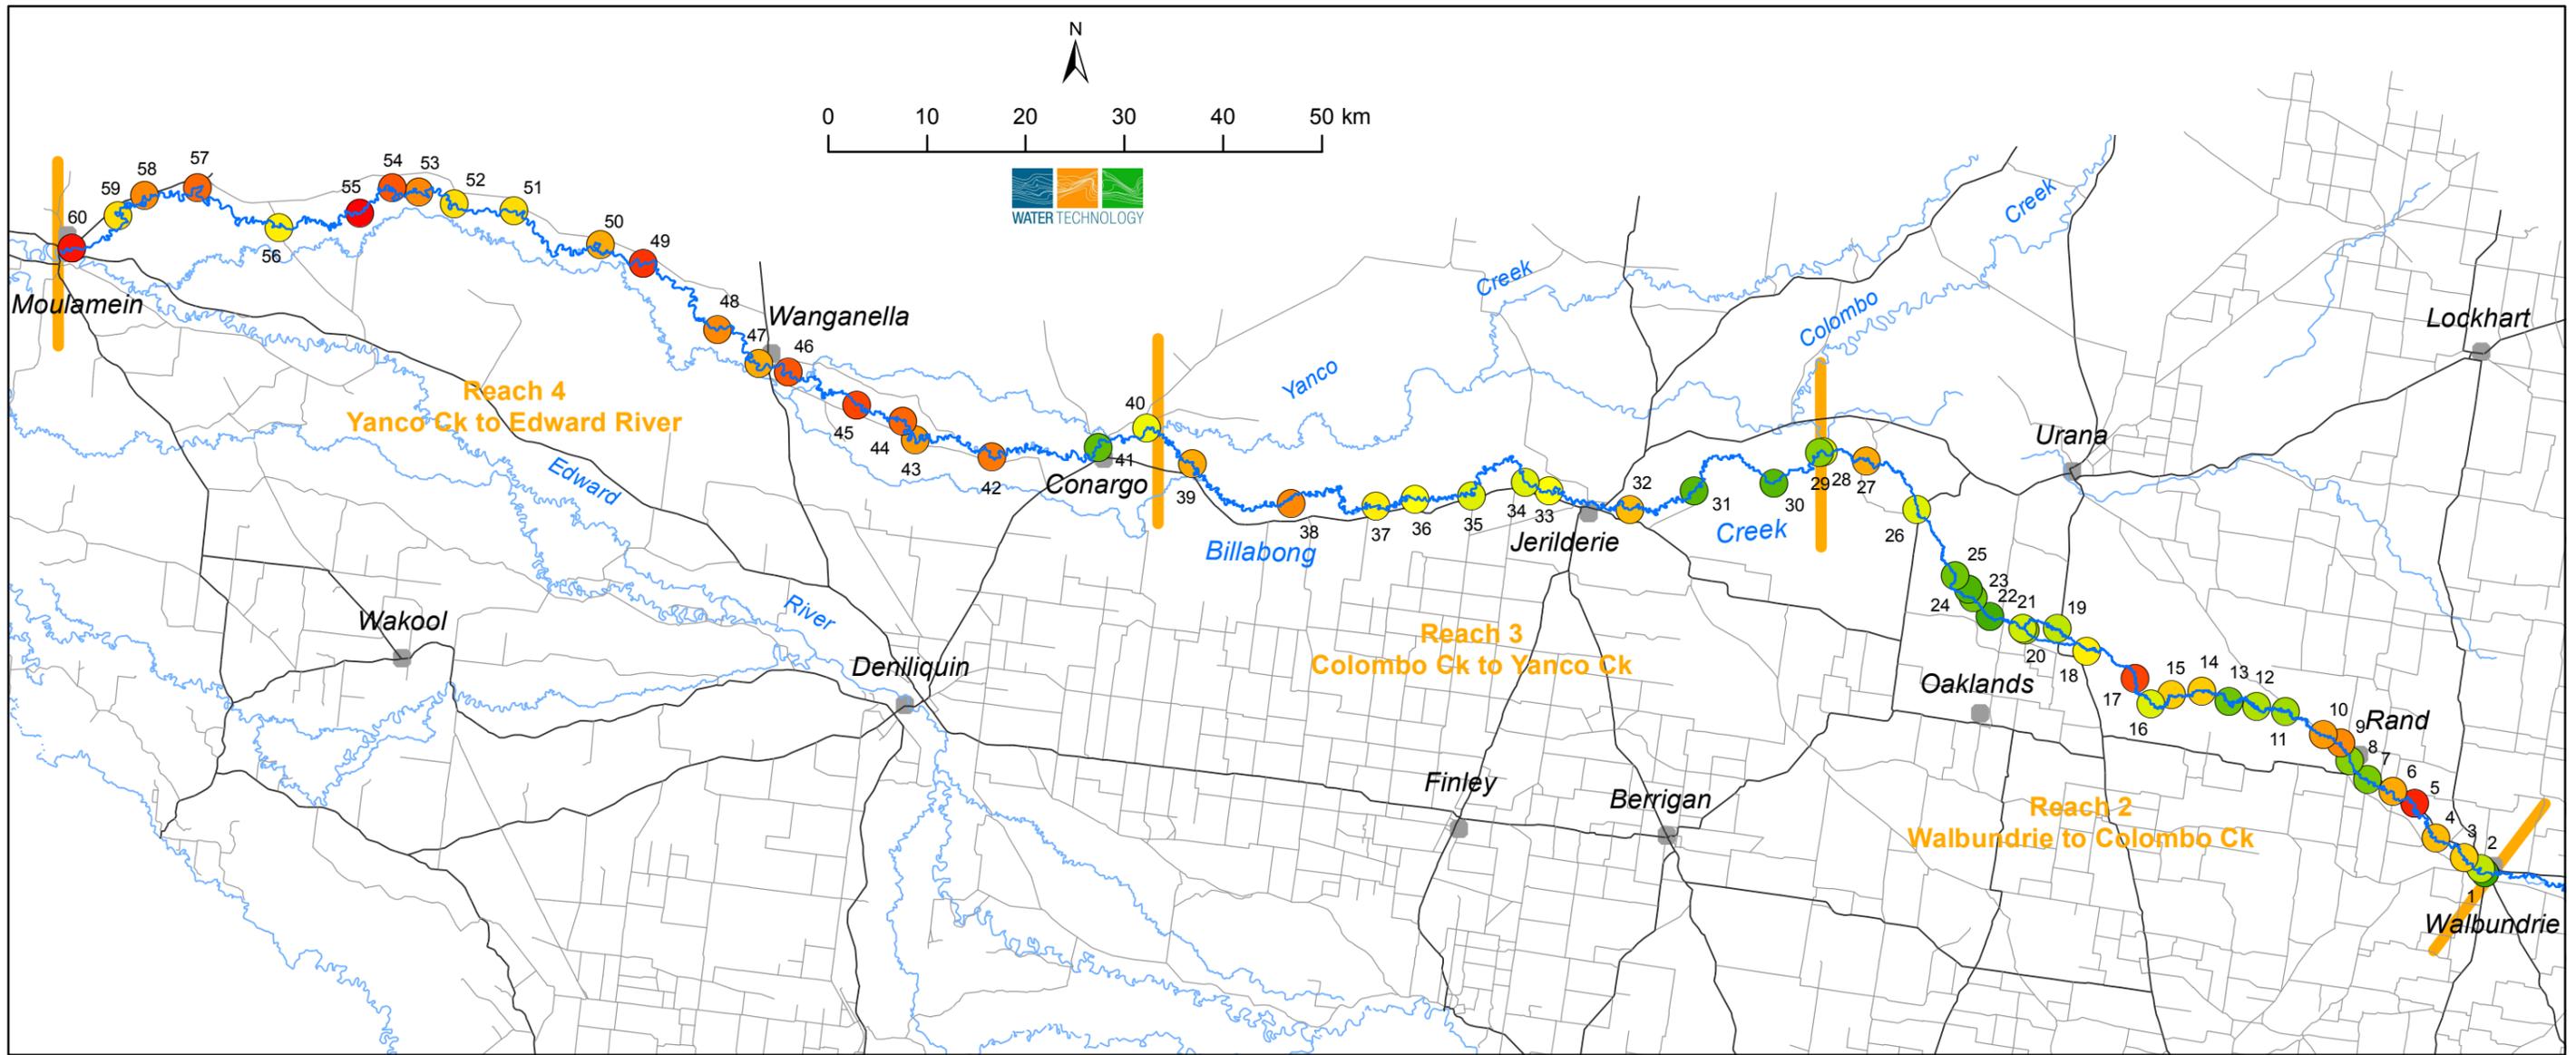
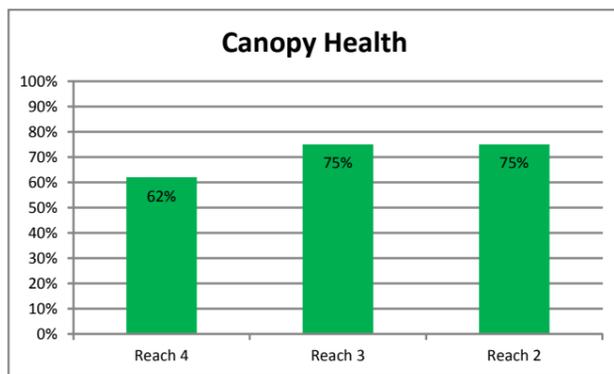
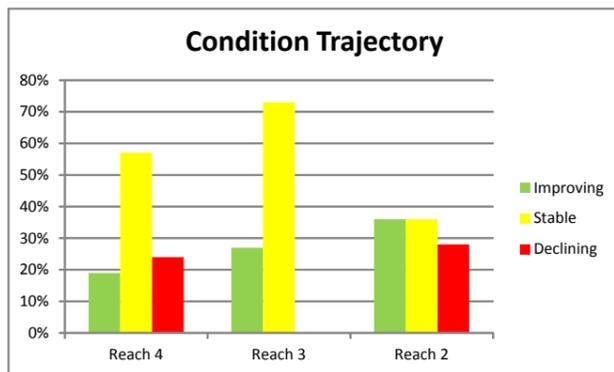
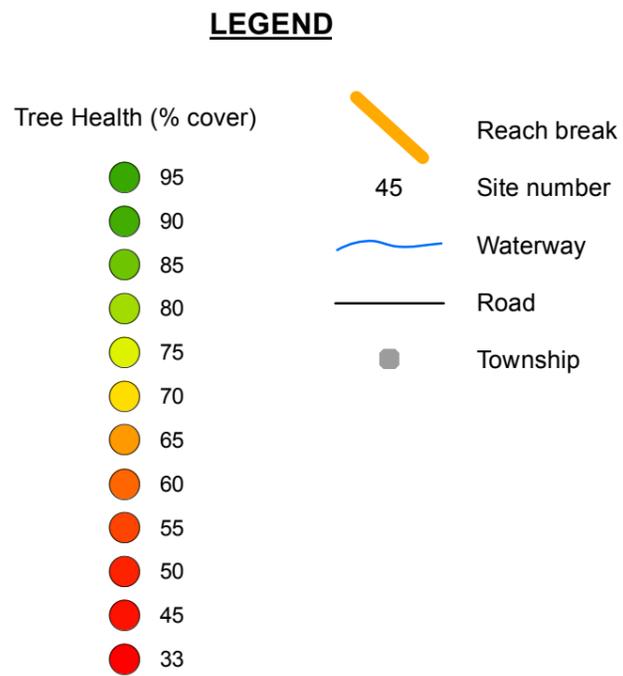
**Billabong Creek**  
**Riparian Vegetation Mapping 2011-12**  
**Canopy Health**  
 Figure 7

While Reaches 2 and 3 had the same ‘proportion of expected healthy canopy cover’ at 75%, Reach 4 was substantially lower at 62%. Reach 4 also shows a distinct decline in tree health as one moves from upstream to downstream (Figure 7). This decline may be attributed to the cumulative effects of water extraction as regulated flows enter the creek via the Yanco Creek only and are therefore steadily diminished through extraction as you move downstream. These conditions would have been exacerbated in the recent drought as demand and consumption of water can be higher relative to average conditions.

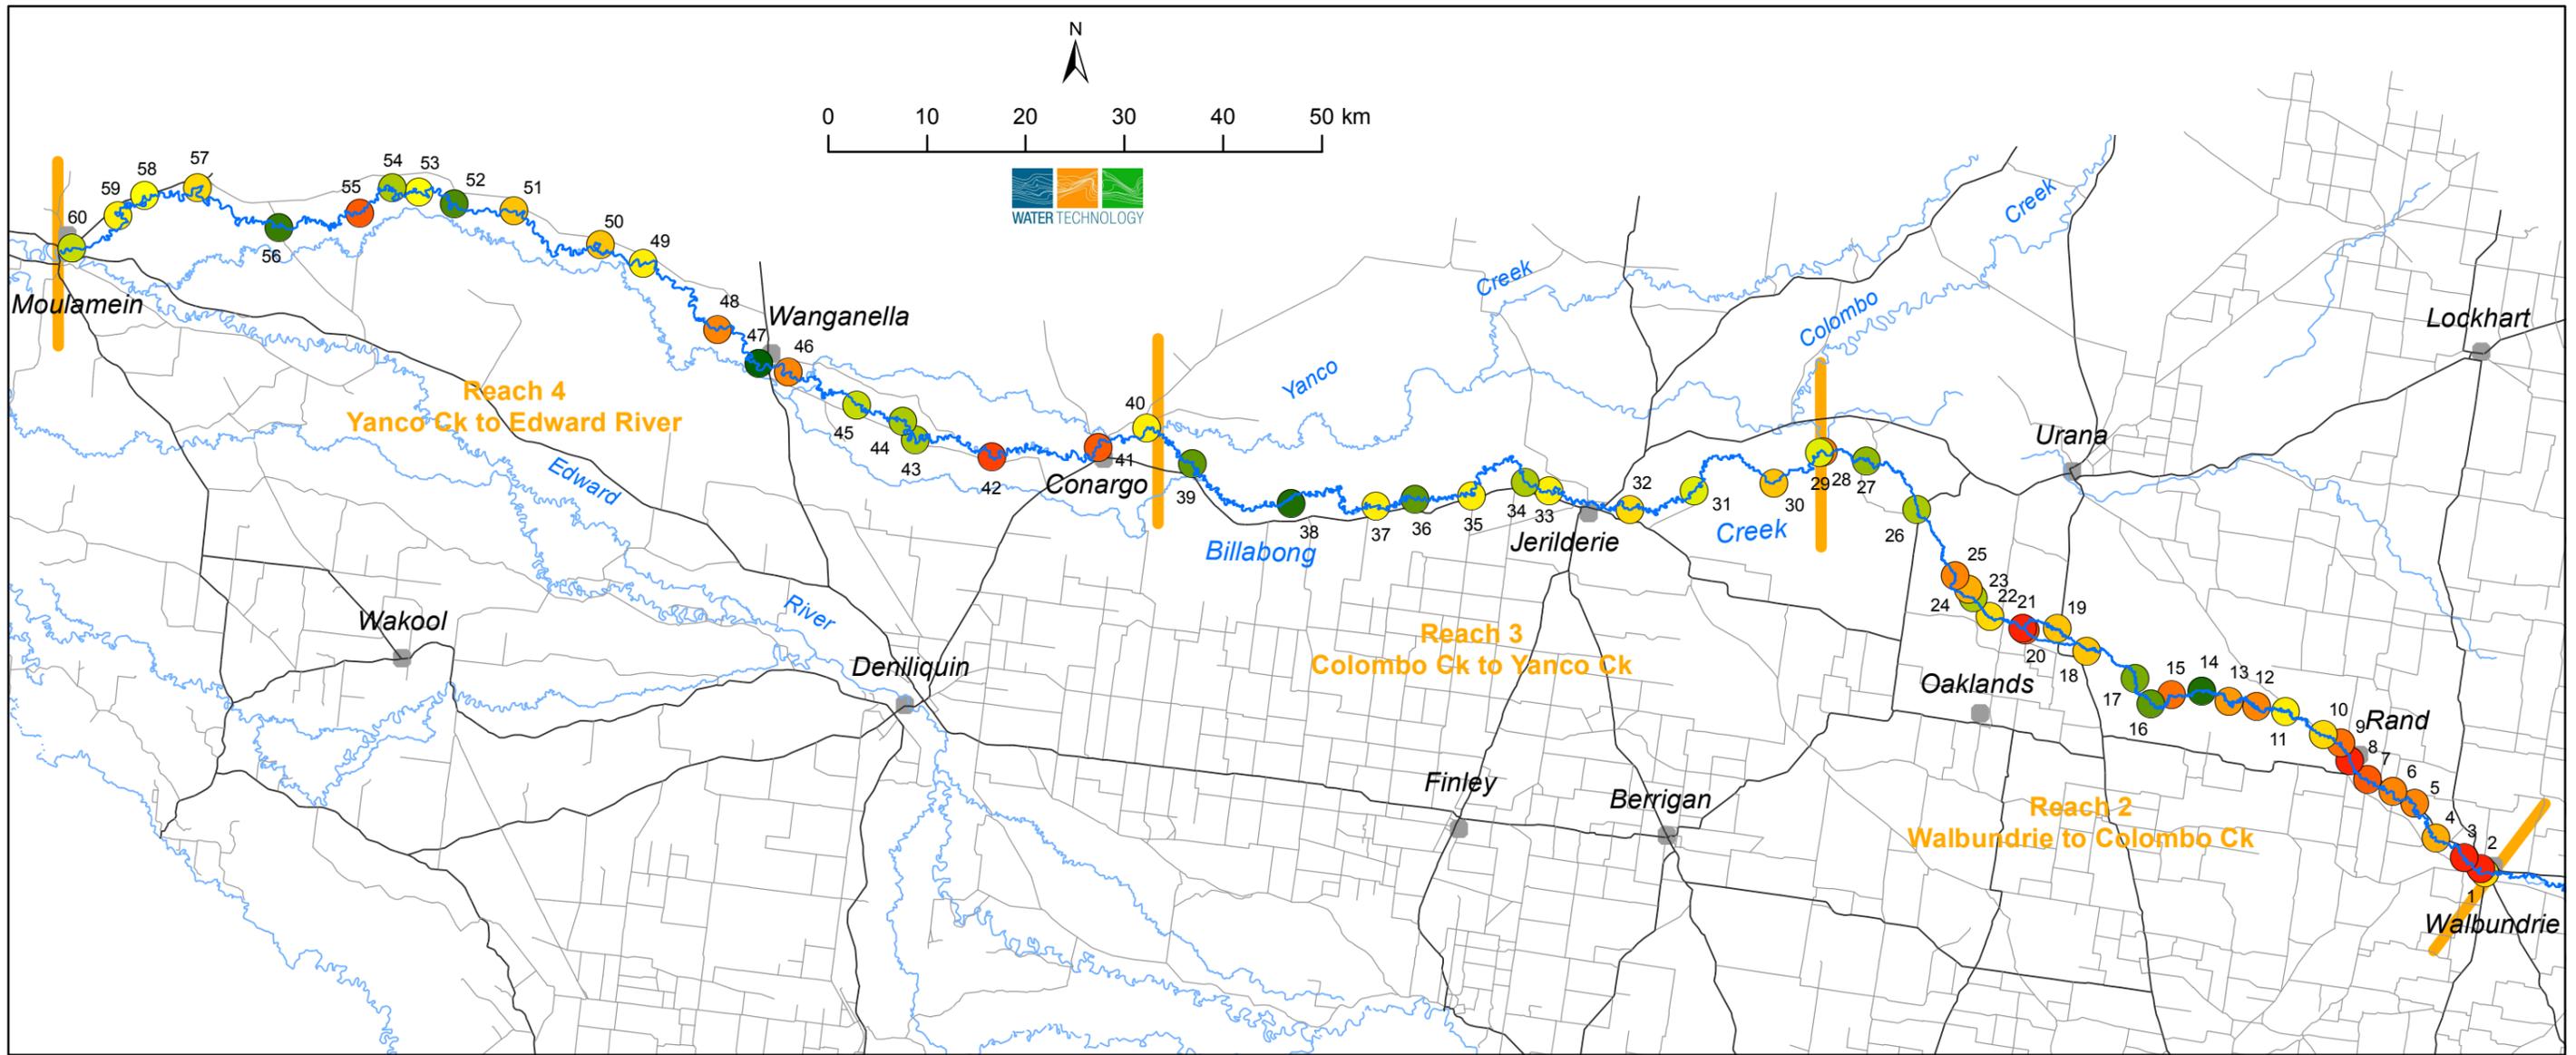
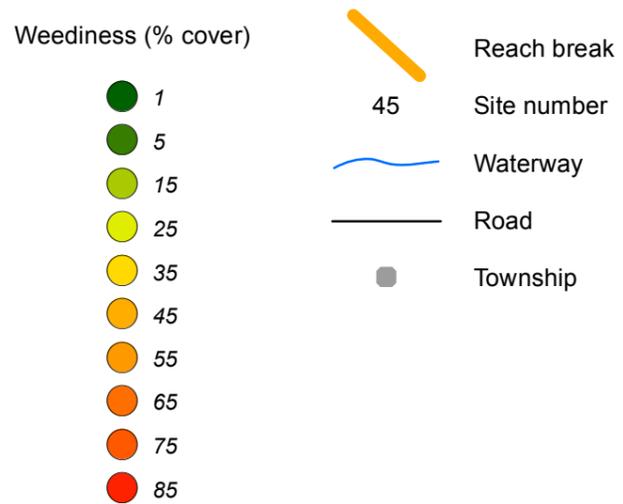
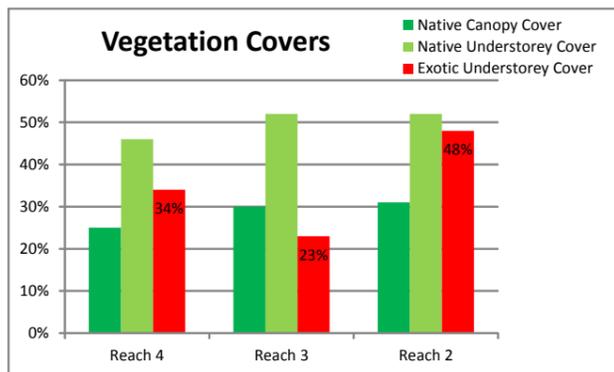
Figure 8

Weed cover percentages are presented graphically in Figure 8. Weed cover is considerably higher in the wetter upstream Reach 2. Reach 3 showed the lowest weed cover percentage, approximately half the cover measured within Reach 2. Although the downstream Reach 4 is weedier than the middle reach, it has a much lower weed cover percentage than the upstream Reach 2.

This cover percentage trend matches the average number of exotic species identified within each Reach as graphed on Figure 3.

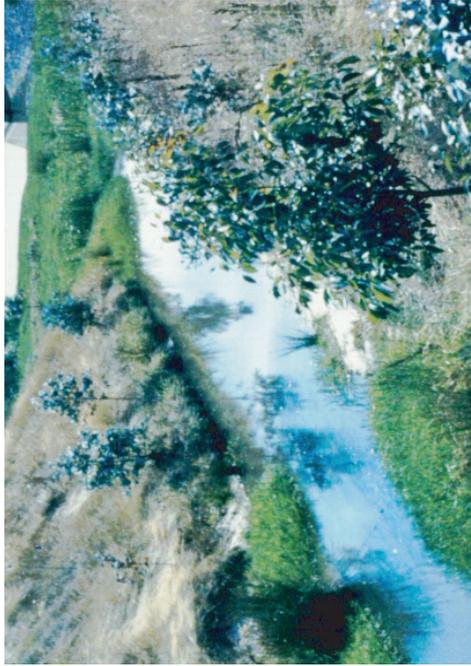
*(Left bank).  
Grass growing  
on much of  
the bank.  
Some woody  
vegetation.  
Isolated local  
slumping which  
does not extend  
far up the bank.*

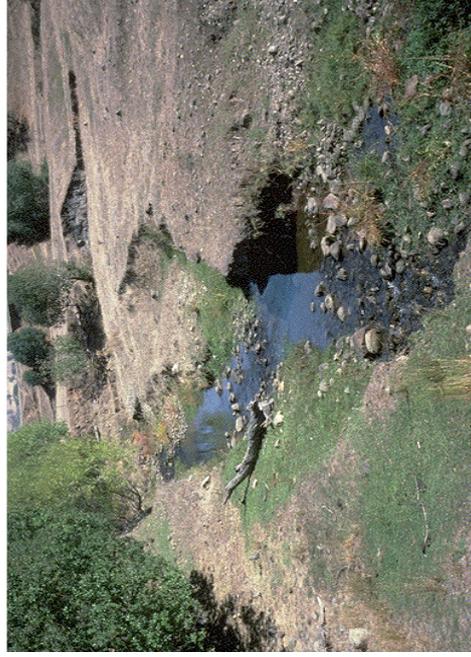
*(Both bank).  
Some small scale,  
isolated bare  
eroding banks.*

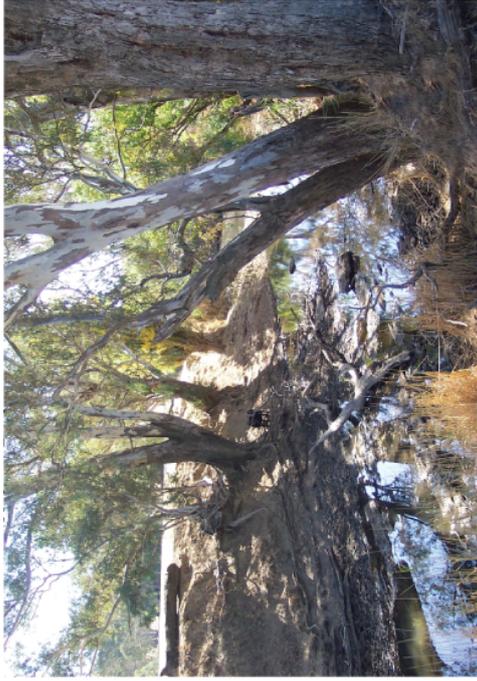
*(Left bank).  
Surficial erosion  
over most of  
bank, but soils  
are clayey and  
seem resistant to  
erosion.  
Toe of bank is  
reasonably stable.  
Discontinuous  
vegetation.*

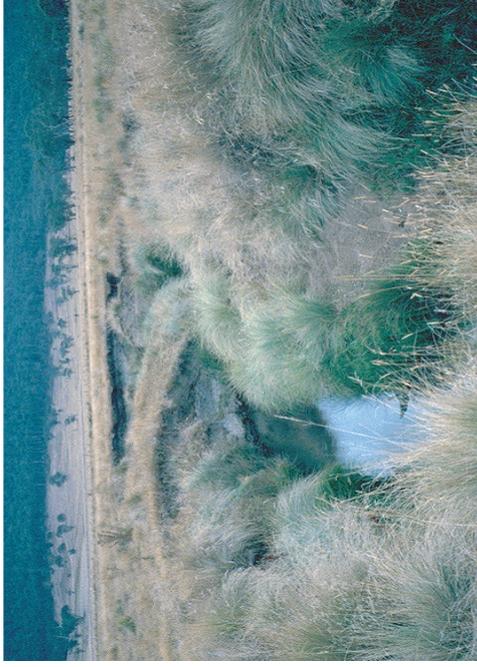
*(Both banks).  
Some  
discontinuous  
slumpings that  
extends to the  
toe of the bank.*

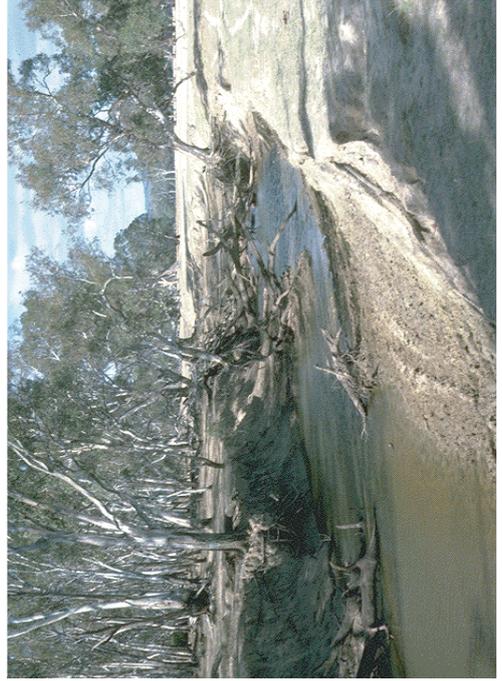
*(Left bank).  
Discontinuous  
erosion.  
Discontinuous  
woody vegetation.  
Minimal grass  
coverage.  
Bank batter varies.*

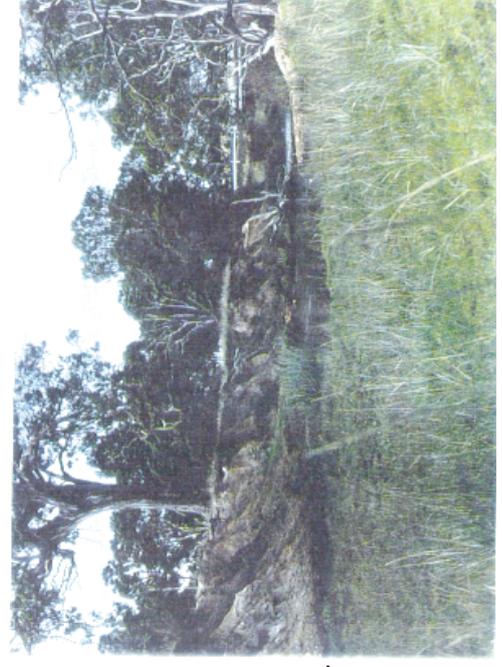
*(Left bank).  
Surficial  
erosion over  
most of bank.  
Toe of bank is  
probably  
reasonably stable.*

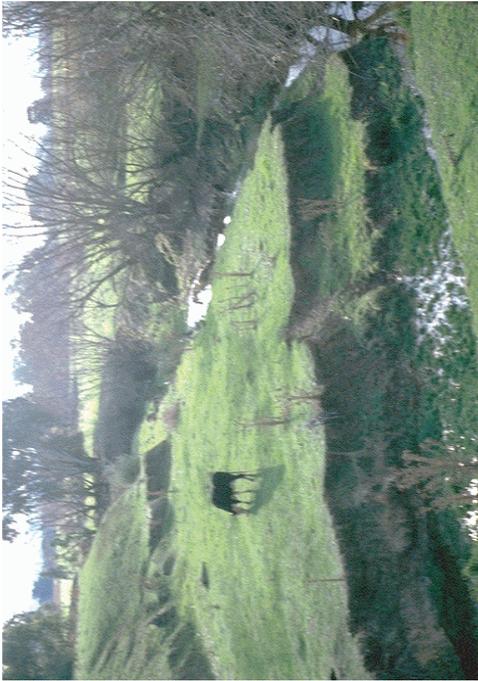
*(Left bank).  
Mostly unstable toe of bank.  
Low vegetation cover.  
Livestock access is unrestricted.*

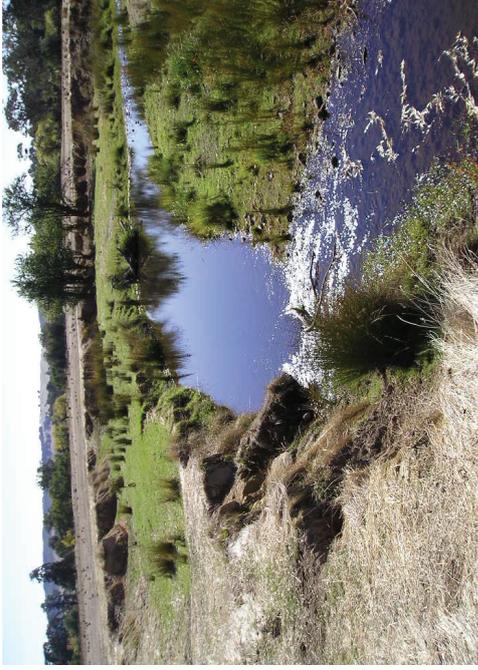
*(Left bank).  
Erosion is occurring along most of bank.  
Bank appears to have some limited resistance to erosion.  
Minimal woody vegetation on bank.*

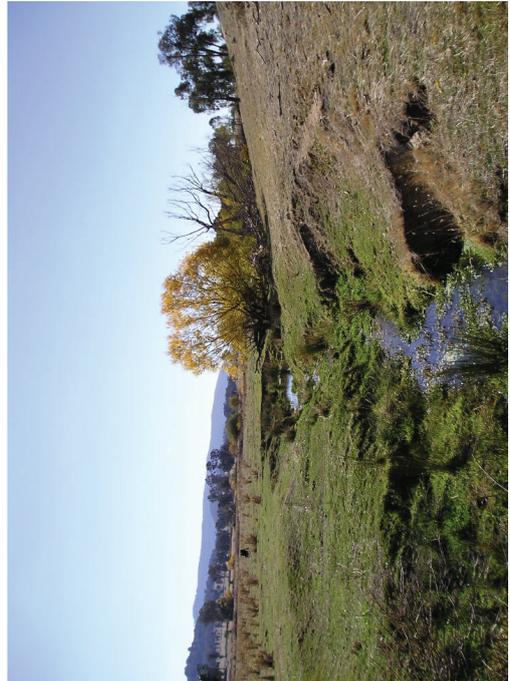
*(Both bank).  
Limited woody vegetation on banks.  
Recent erosion and slumping of banks.  
Unstable toe of banks.*

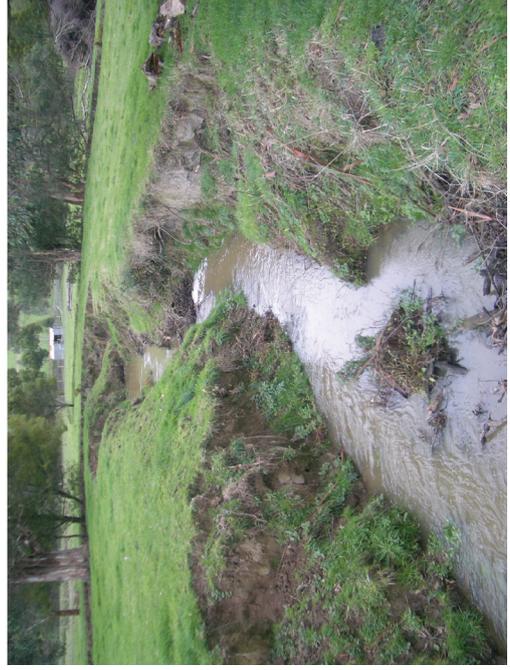
*(Both banks).  
It is likely that recent deepening has taken place, and triggered erosion of both banks.  
No woody vegetation on banks.*
