**Local Land
Services**
South East

Supporting Information for the development of a River Rehabilitation Plan for Araluen Creek and Tributaries.

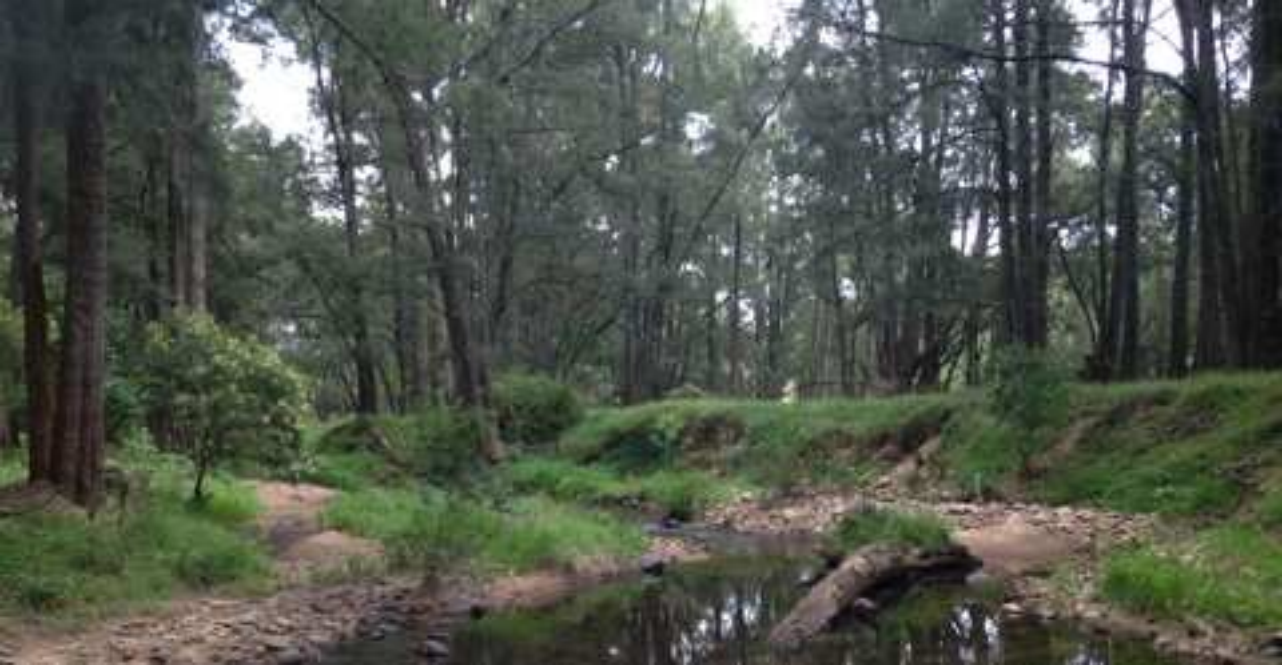
Figure 6: A view of riparian vegetation along Araluen Creek, downstream of "site 3".

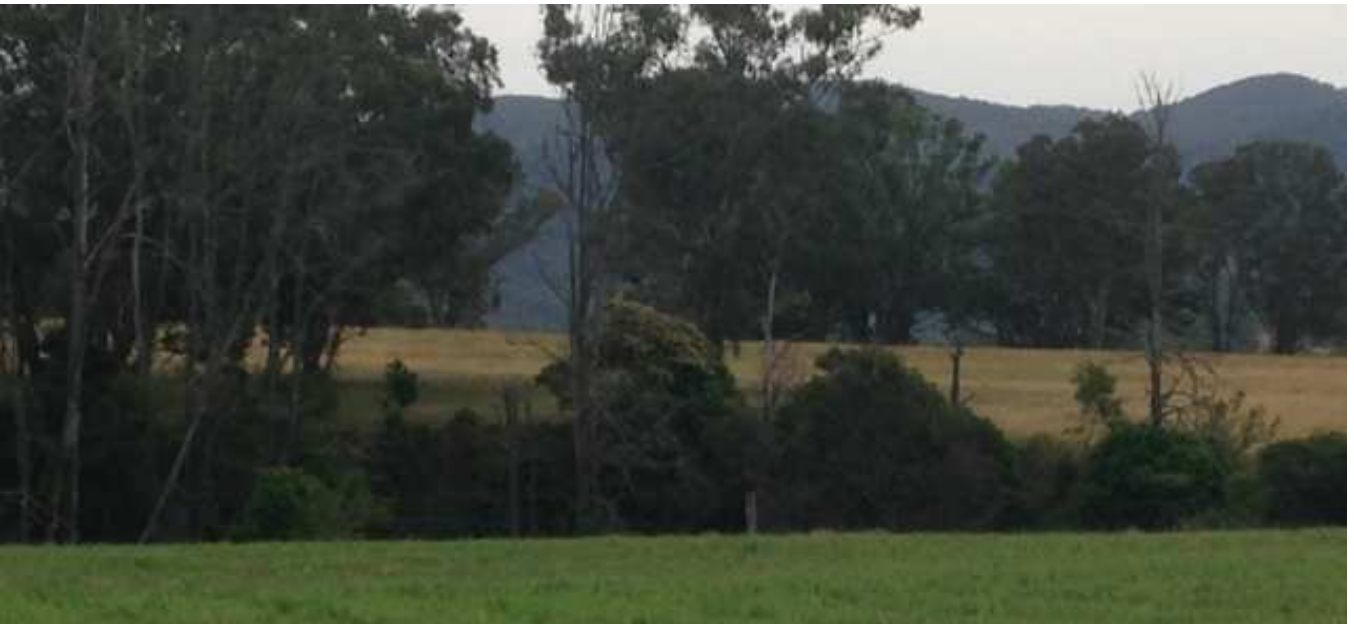
Figure 9: remnant vegetation patches along Oak Creek.

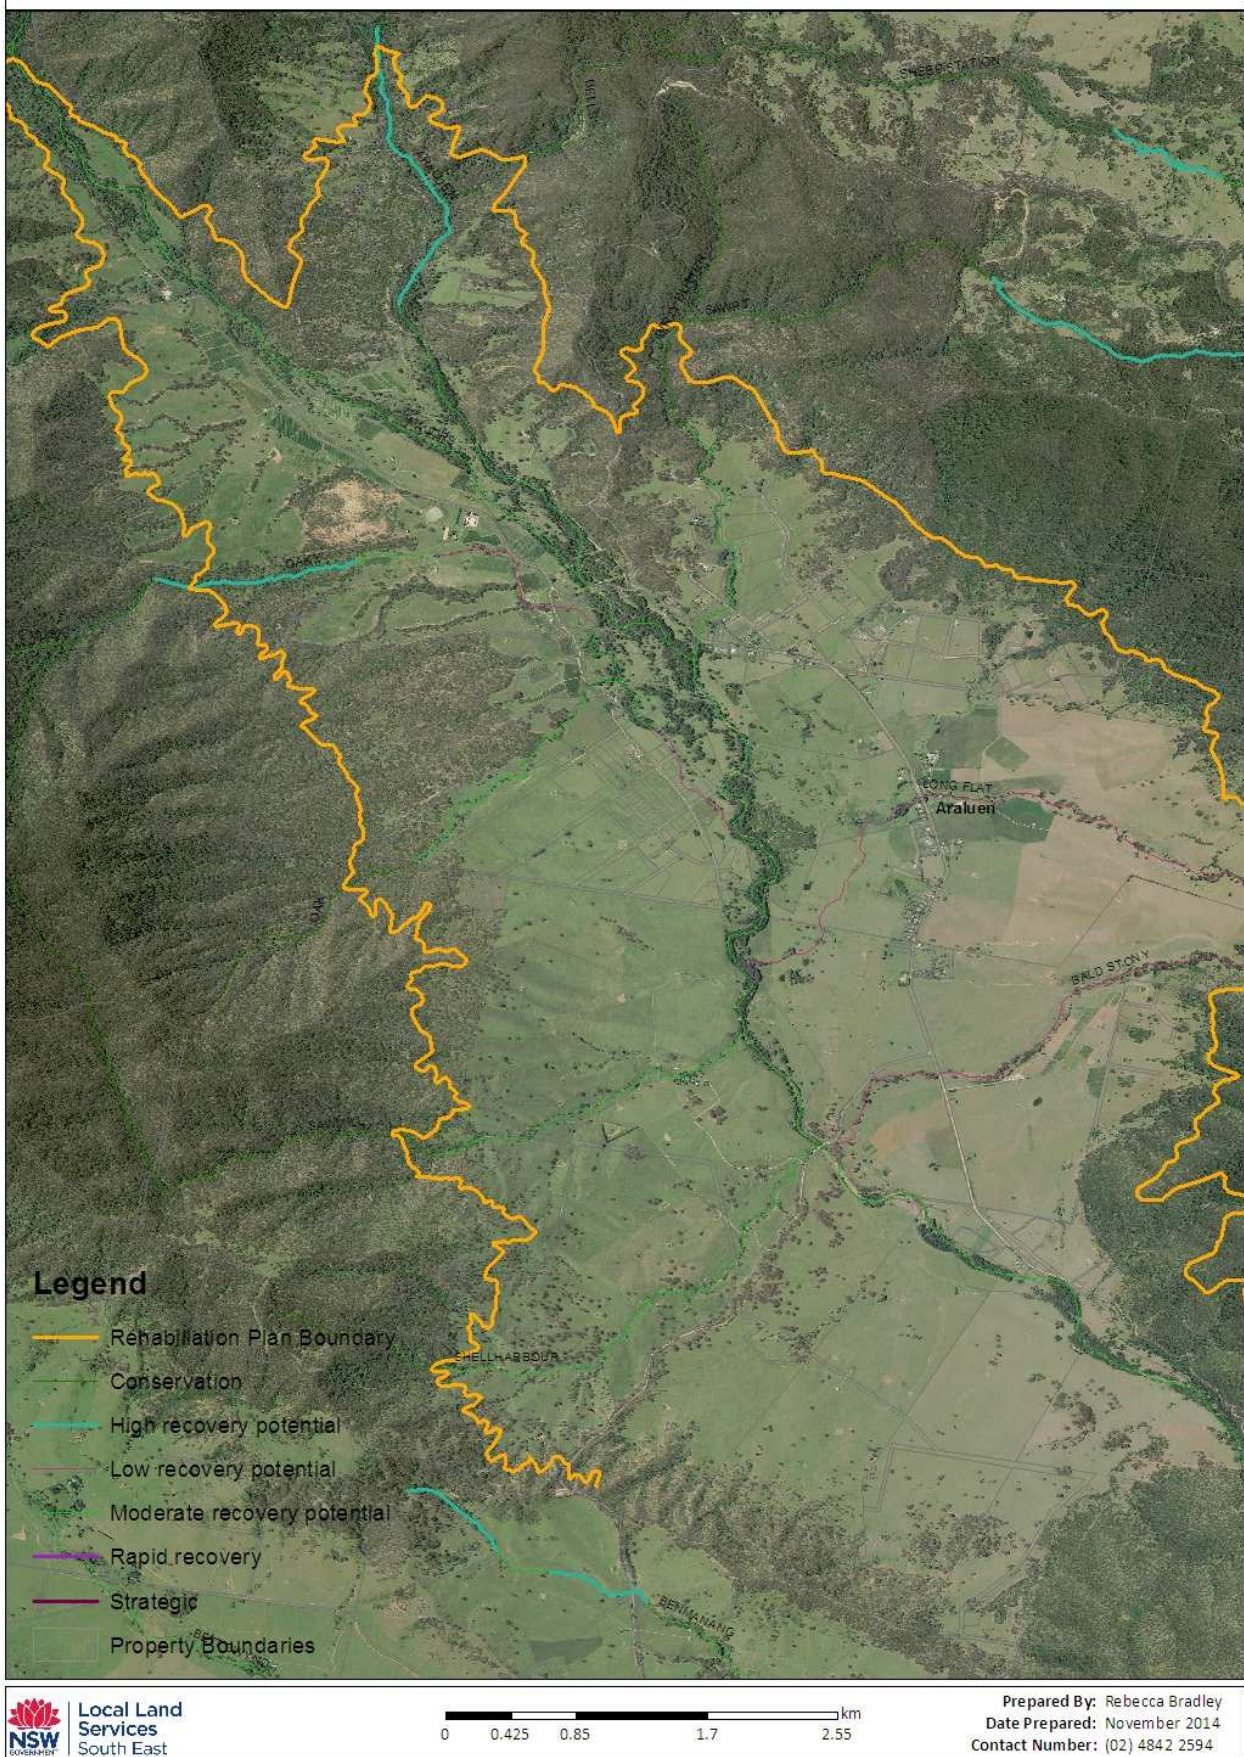
- Moderate to poor geomorphic condition.
- Potential to recover at a slow to moderate rate if existing pressures are removed (eg livestock access).
- Recovery presently occurring at a slow rate.
- Little sediment, seed or large woody debris input (if required to allow channel contraction recovery) or;
- Excess sediment supply in moderate slugs.
- Can only recover faster if upstream reaches are rehabilitated and this reach receives rehabilitation works.

Figure 12: Riverstyles Recovery Potential

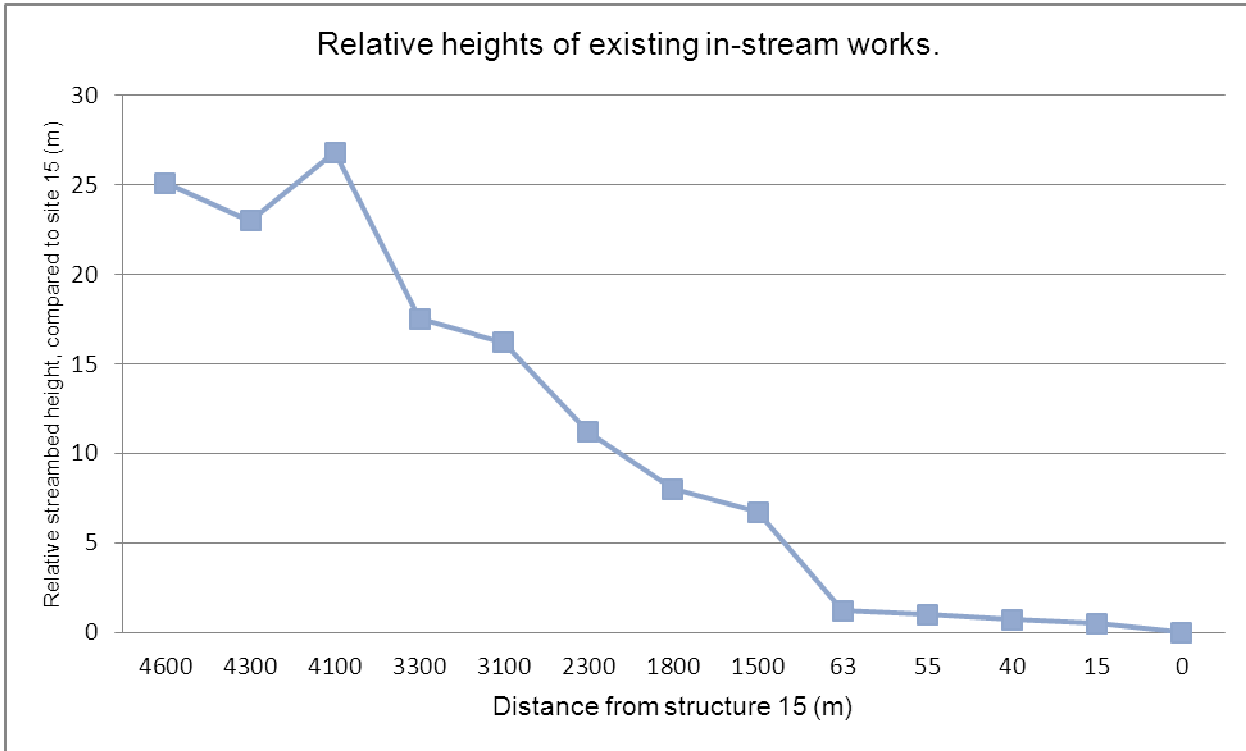
Figure 1: Graph demonstrating the long section along Araluen Creek between sites 1 – 15, above the Nerringla Road Bridge.
