Upper Deua Landcare. Araluen Creek Restoration Project

Cost Estimates and Priorities

Soil Conservation Service

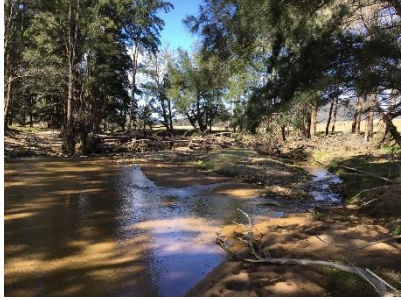
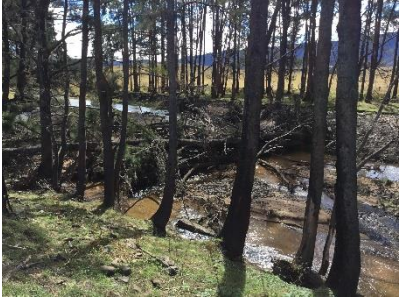
<p>5. Mundy. Big tree choke diverting flows into banks and bed</p>	<ul style="list-style-type: none"> • Realign fallen trees to prevent floodwater causing erosion to bed and banks, and possible causing creek to permanently realign around choke.

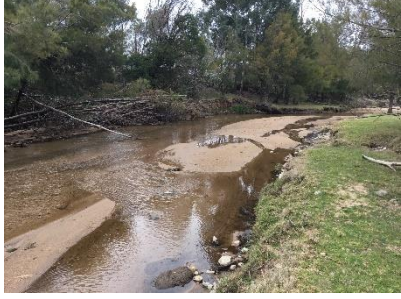
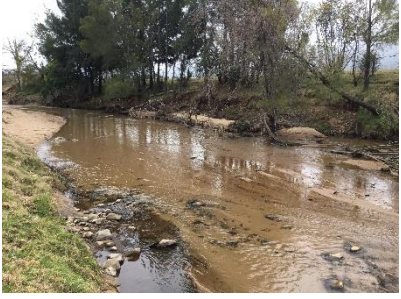
<p>High</p>	<p>\$5,695</p>
<p>6. Mundy. Erosion at former sand sausage site</p>	<ul style="list-style-type: none"> • Install rootballs at base of erosion to slow floodwater and trap sediment, reducing erosion of the outer bank. • Possible relocation of sediment on inside of bend, subject to negotiation with landholders (Laurie).

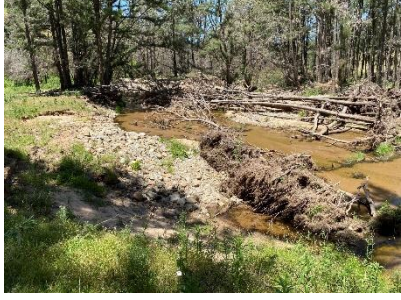
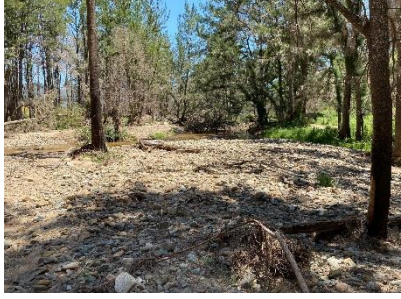
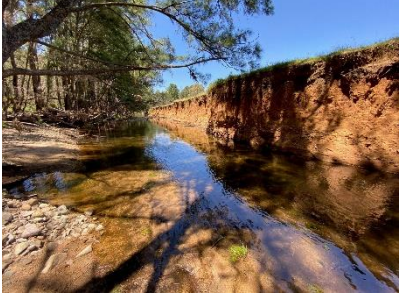
<p>High</p>	<p>\$16,270</p>
<p>7. Collet. Flood diversion leading to severe bank erosion, and other problems</p>	<ul style="list-style-type: none"> • Install rootballs along eroding alignment and open up channel to prevent further erosion. • Remove large choke in floodrunner. • Excavate entrance to floodrunner allowing flood capacity. • Other small scale bank works by realignment and rootball / fallen tree installation where necessary.

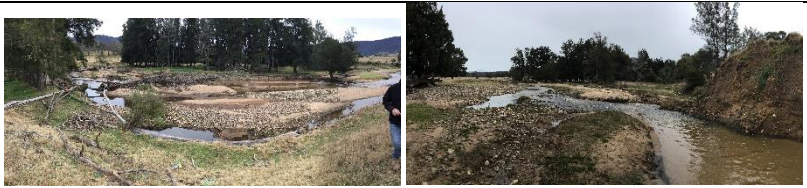
<p>8. Laurie. Fallen trees and bed erosion</p>	<ul style="list-style-type: none"> • Realign fallen trees to prevent bank scour. • Install log sill below site to prevent bed erosion migrating upstream.

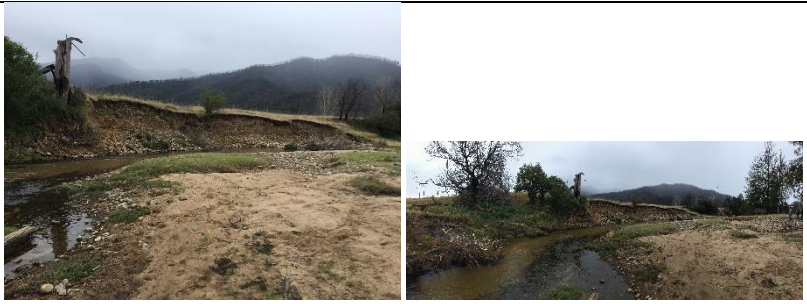
<p>Med</p>	<p>\$10,065</p>
<p>9. Laurie. Severe erosion of outside bend</p>	<ul style="list-style-type: none"> • Install rootballs in bank toe to prevent erosion. • Realignment of channel closer to middle of creek.

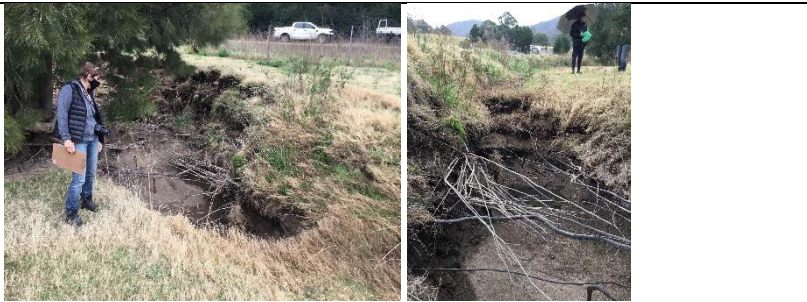
<p>High</p>	<p>\$15,475</p>
<p>10. Michael. Severe bed erosion above main road crossing, Dirty Butter Creek</p>	<ul style="list-style-type: none"> • Install log weir and rock drop structure to prevent erosion migrating upstream.

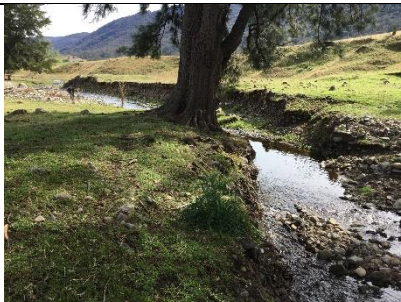
<p>12. Ken Harrison. Bed erosion downstream of concrete crossing</p>	<ul style="list-style-type: none"> • Install two log weirs with rock drop protection to prevent bed erosion worsening.
